TERRA INSIGHT

Balgownie Mountain Bike Trail Network, Balgownie NSW
Report on Preliminary Geotechnical Assessment

Our Ref: TERRA22-223.Rep1.Rev1

4 April 2023

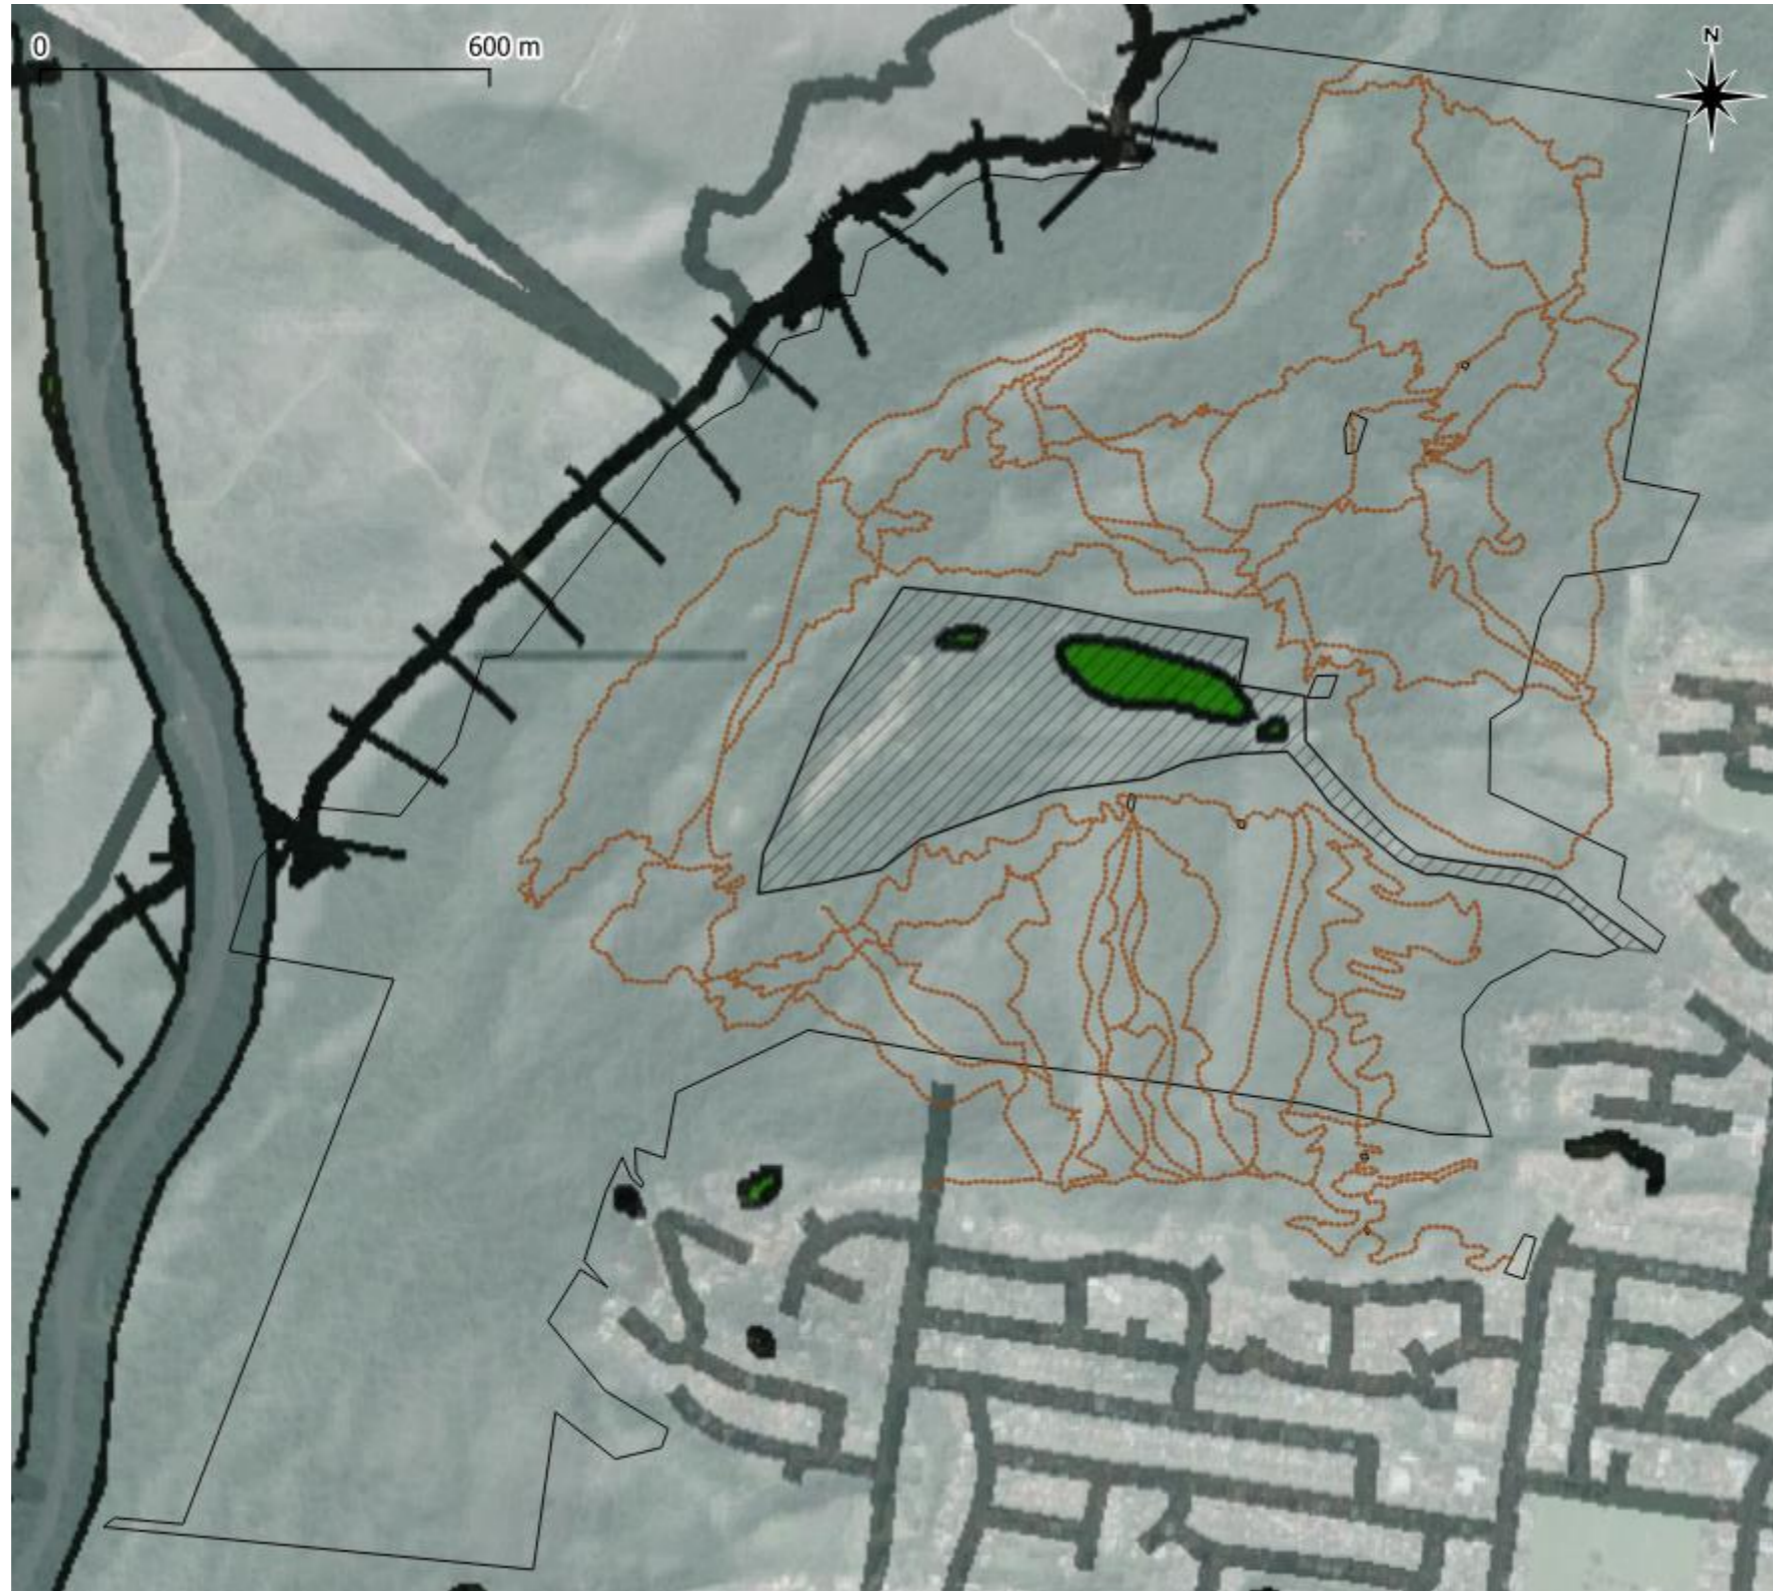
Flentje et al 2005 Landslip Mapping

- One large scale and two small to medium scale slips in the former Corrimal Colliery Property. The eastern two slips have occurred along the access road to the Colliery and to our knowledge, based in previous inspections of this property, are associated with filling activities along the road shoulder especially were positioned across drainage gullies. The western slip is situated above the pit top and appears to be associated with the failure a very steep slope (potentially a cutting) in alignment with a drainage channel.

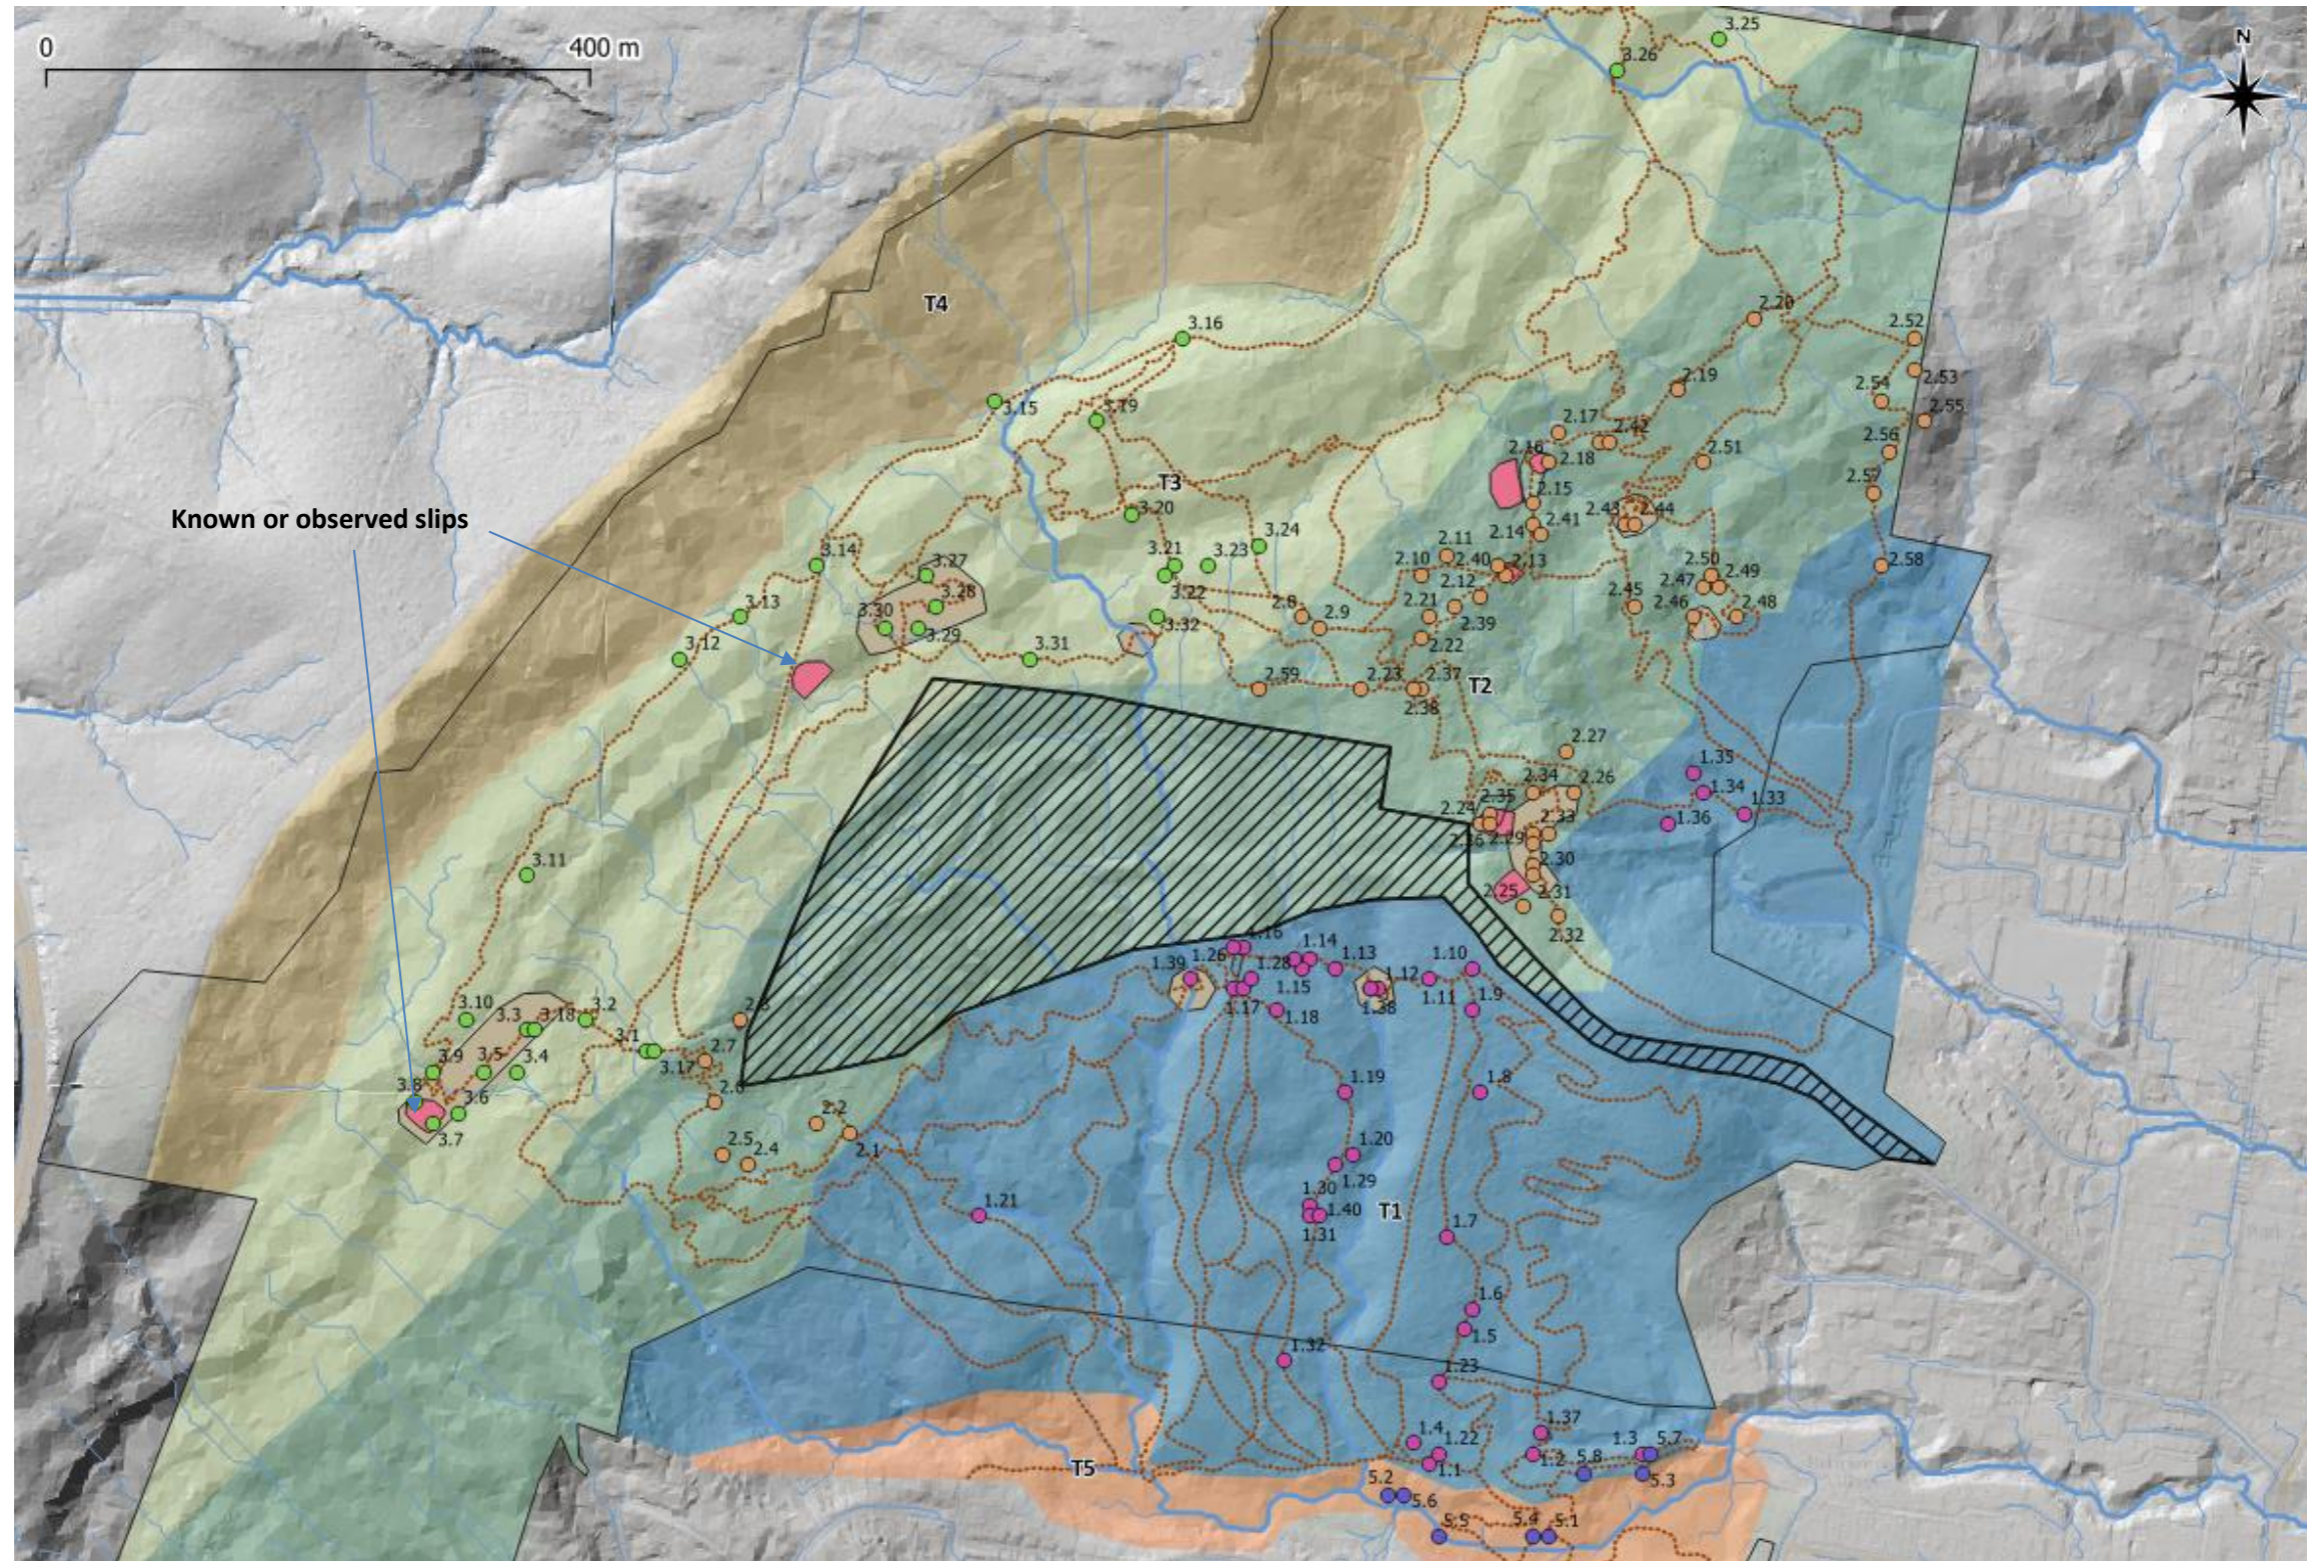
Site Observations

Terra has observed the site as part of the investigation. Known slips and slips observed during the site inspection are included in Figure 10. These slips are typically associated with cutting and filling activities in topographically unstable positions and more extremely sloping natural slopes. Observations within the Terrain Units are as follows:

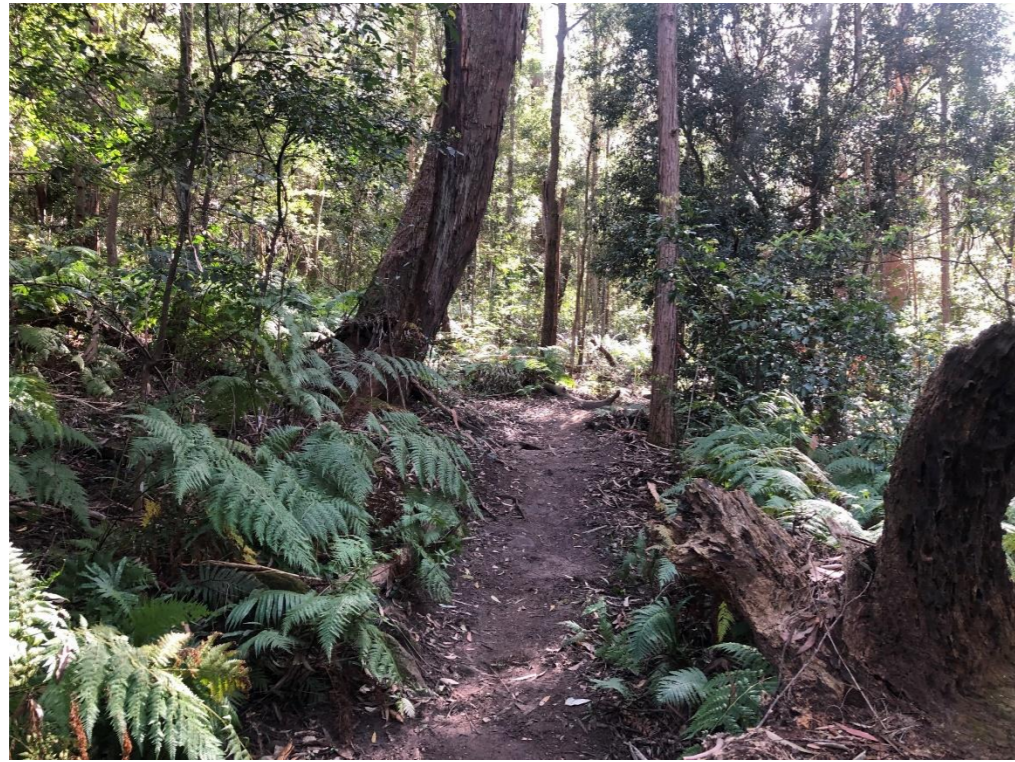
Terrain Unit 1 Photograph 1: Typical terrain along trails in T1, SW. Photo taken along Trial 7.

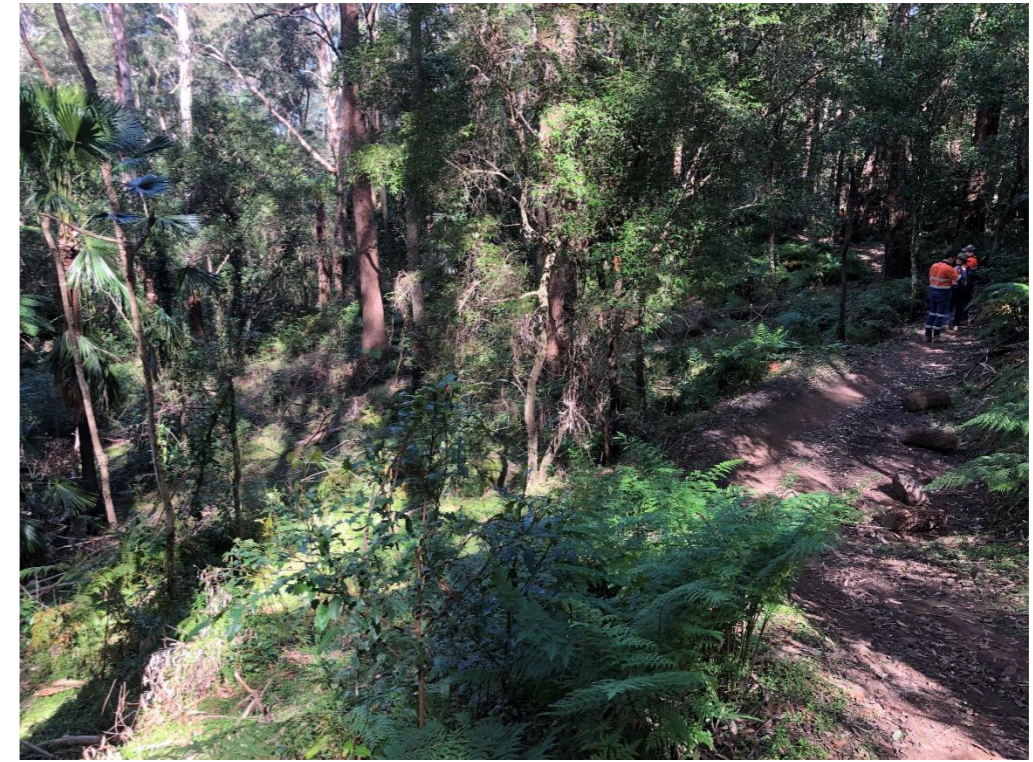
Terrain Unit 1 Photograph 2: View of steeply sloping gully slopes along T1 SW. Photo taken along Trail 8.

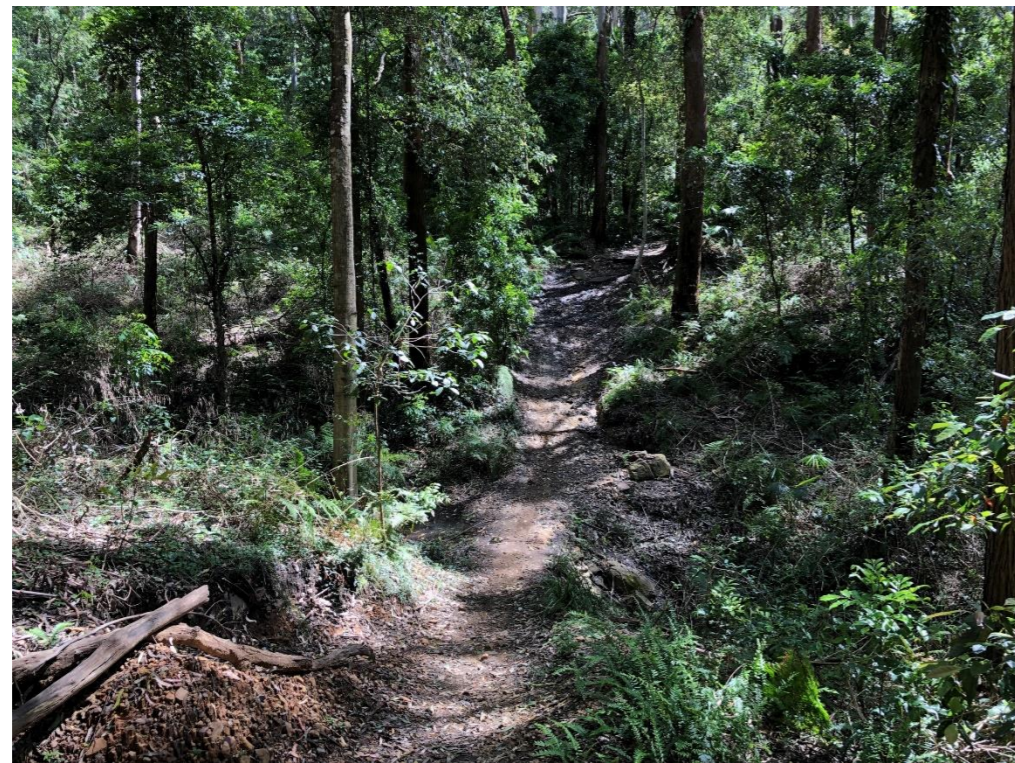
Terrain Unit 1 Photograph 3: View of minor gullies that the trail traverses. Photo taken along Trail 8.

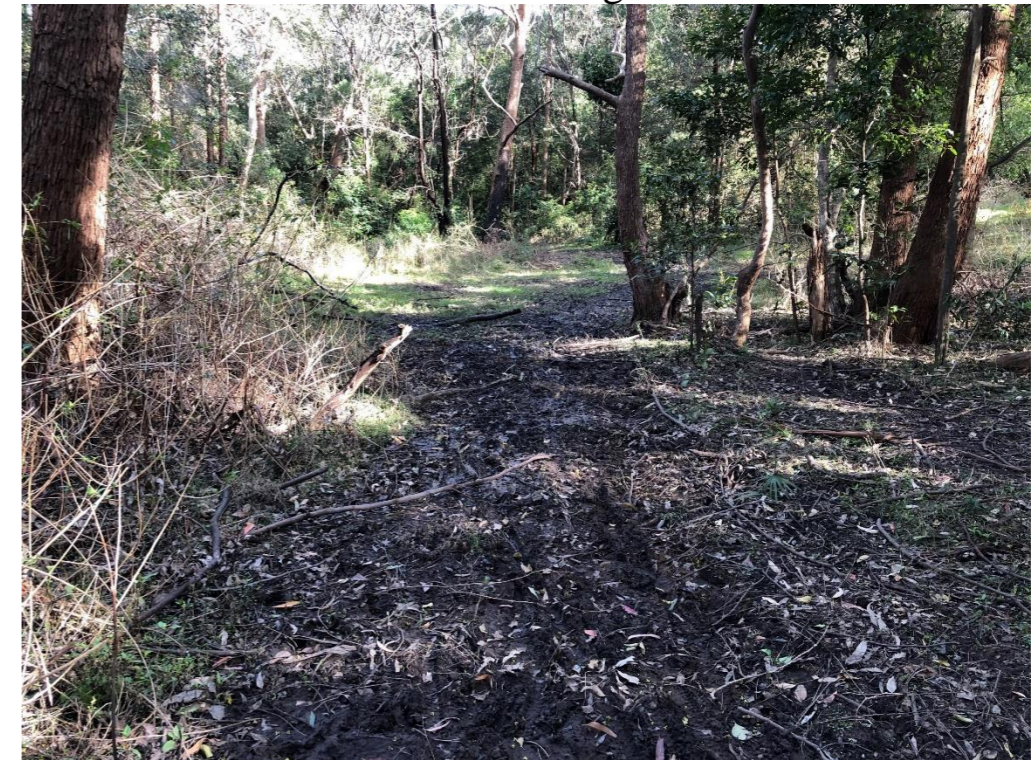
Terrain Unit 1 Photograph 4: Area of seepage observed at the toe of T1. Photo taken along Trail 6.

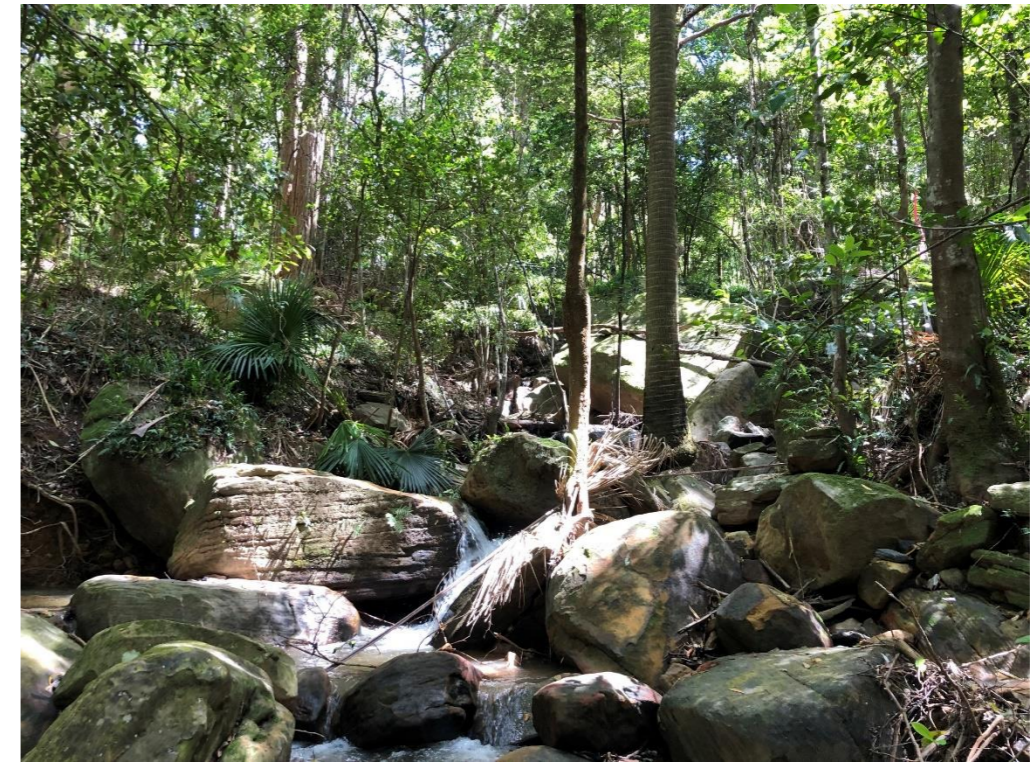
Terrain Unit 1 Photograph 6: Boulder filled creek along active channel.

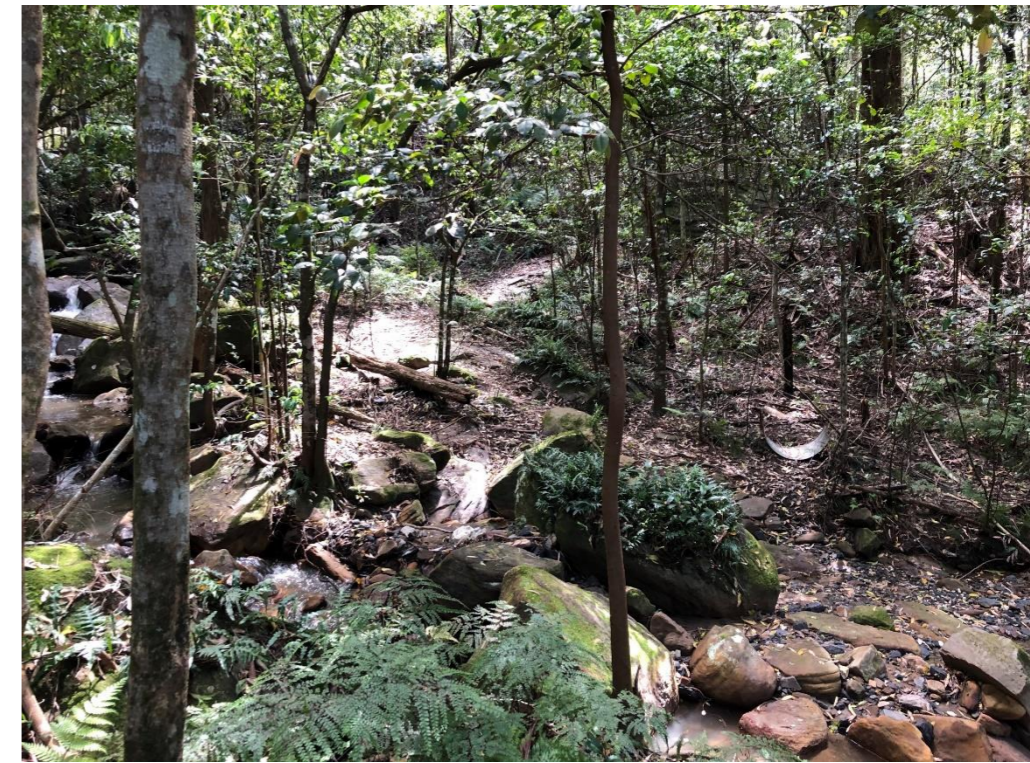
Terrain Unit 1 Photograph 8: View of wide channel base to the east.

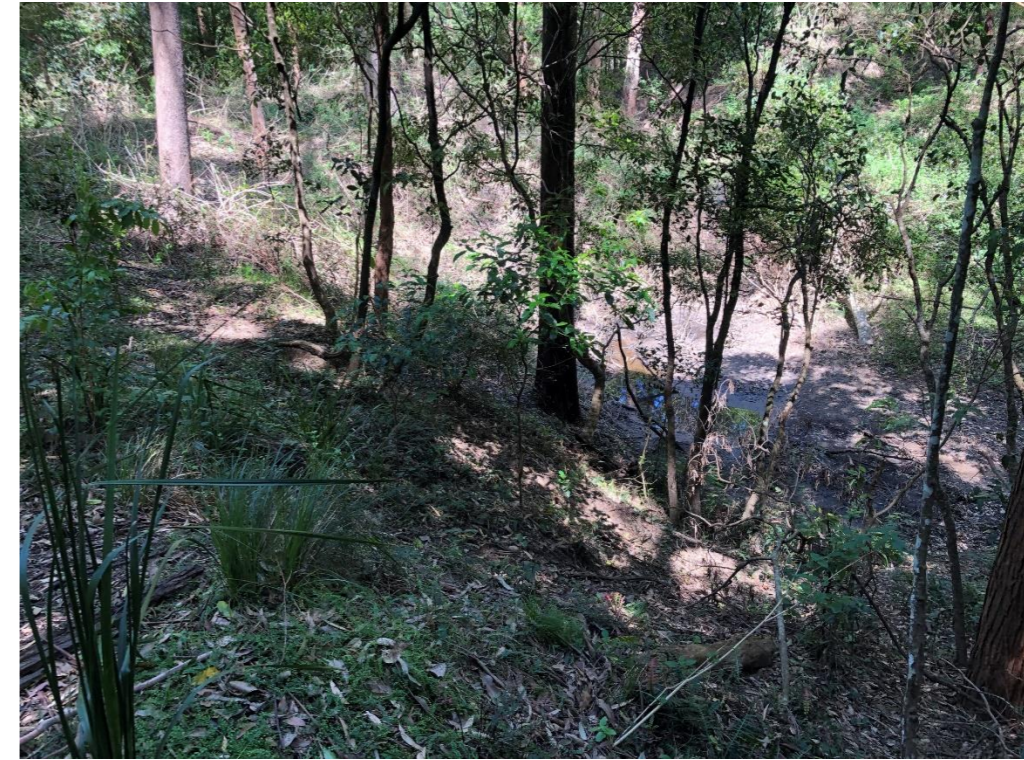
Terrain Unit 1 Photograph 10: View of old earthworks with drainage channel nearby Trail 30.

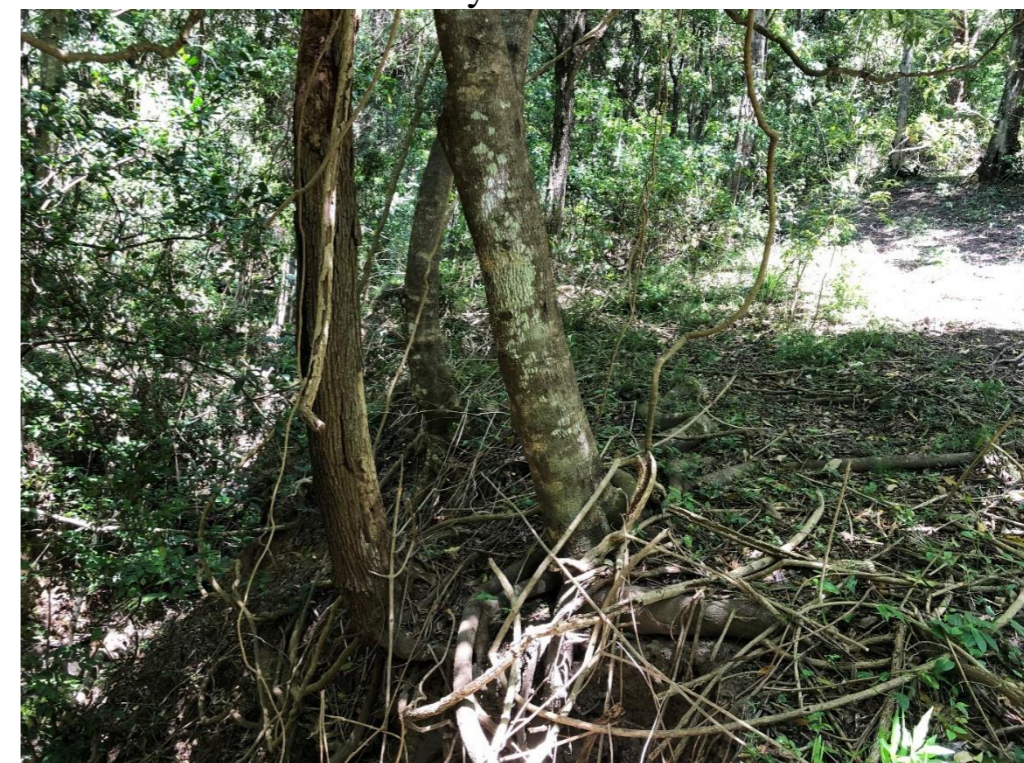
Terrain Unit 1 Photograph 12: Incised creek near Trail 30.

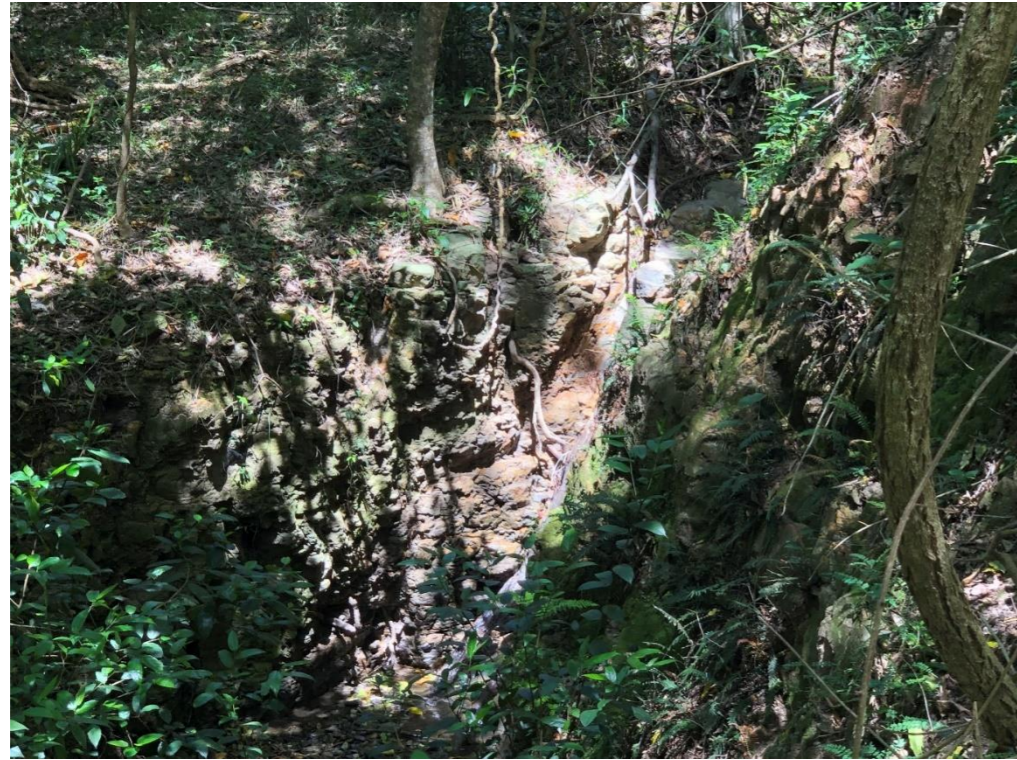
Terrain Unit 1 Photograph 13: Outcropping rock at shallow depth within incised creek.

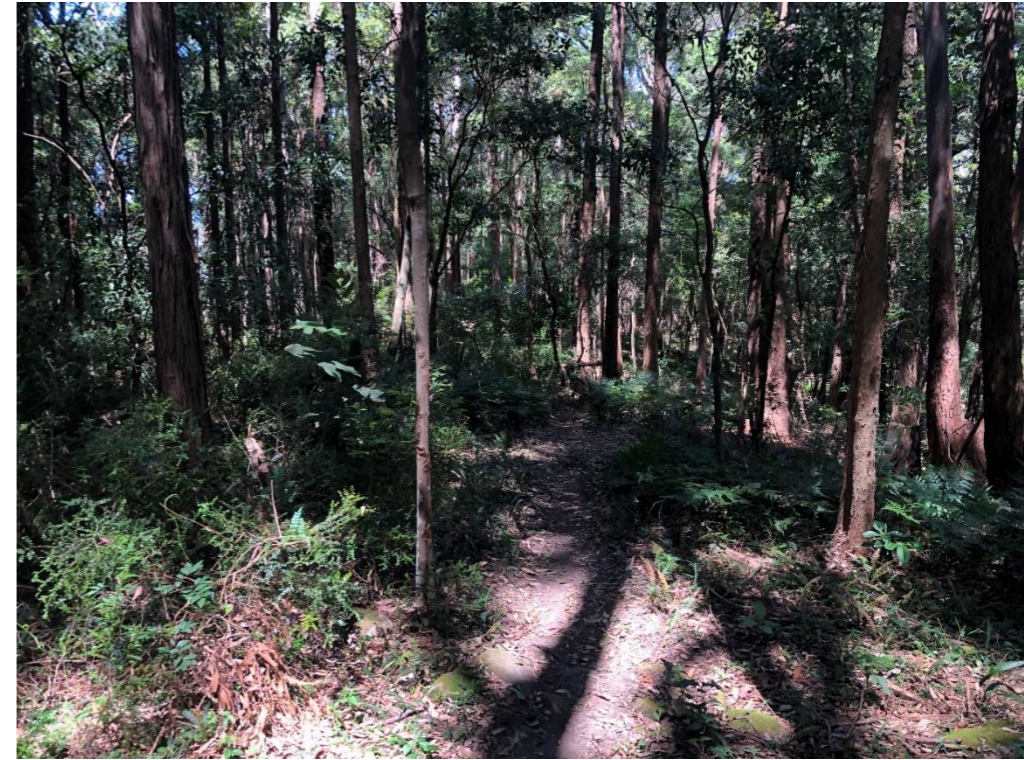
Terrain Unit 1 Photograph 14: Gentle ridge slope that Trails 12 and 13 follows in T1, NE.

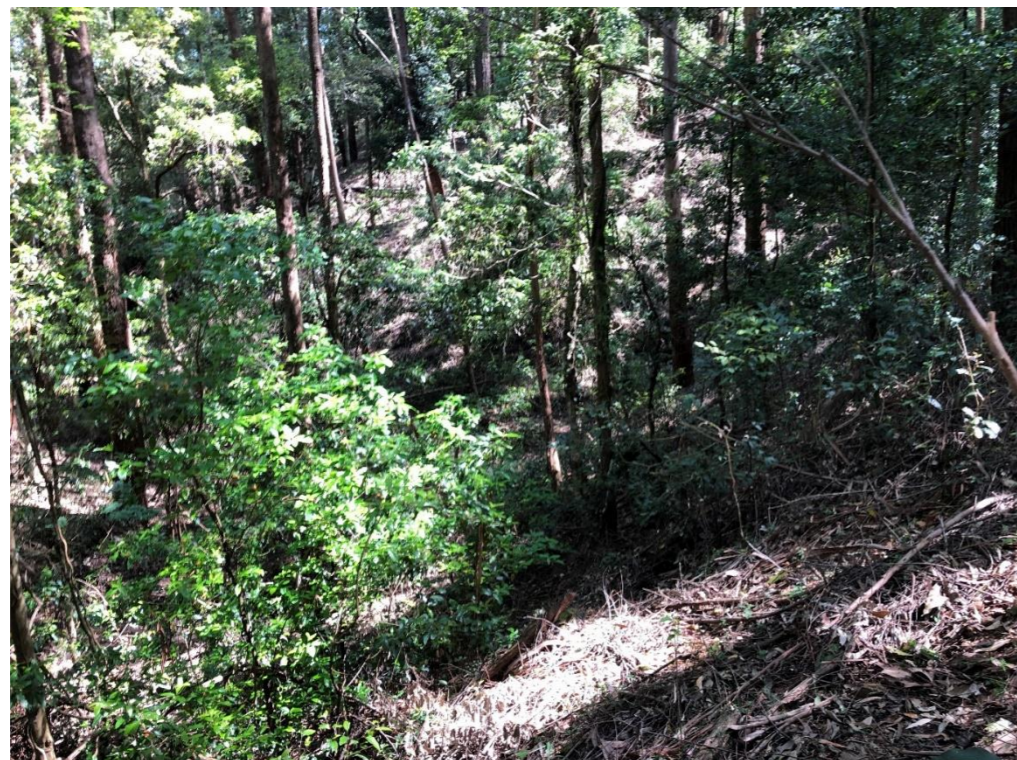
Terrain Unit 1 Photograph 15: Locally steep slopes that Trail 35 follows.

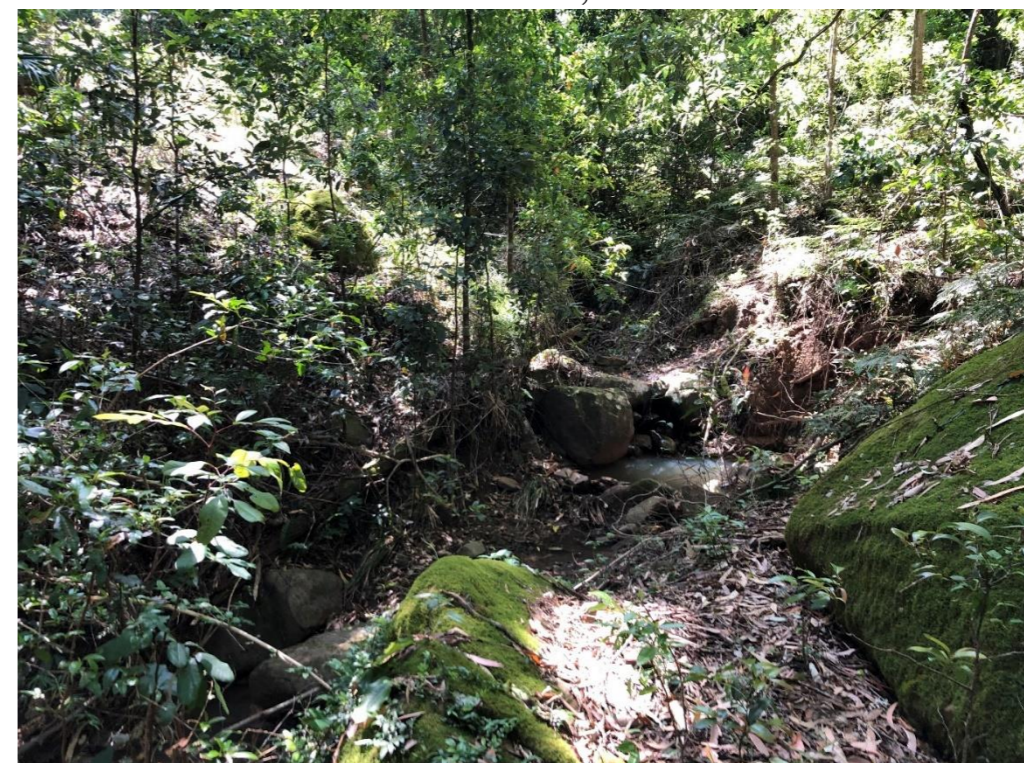
Terrain Unit 1 Photograph 16: Incised minor gullies along Trail 35.

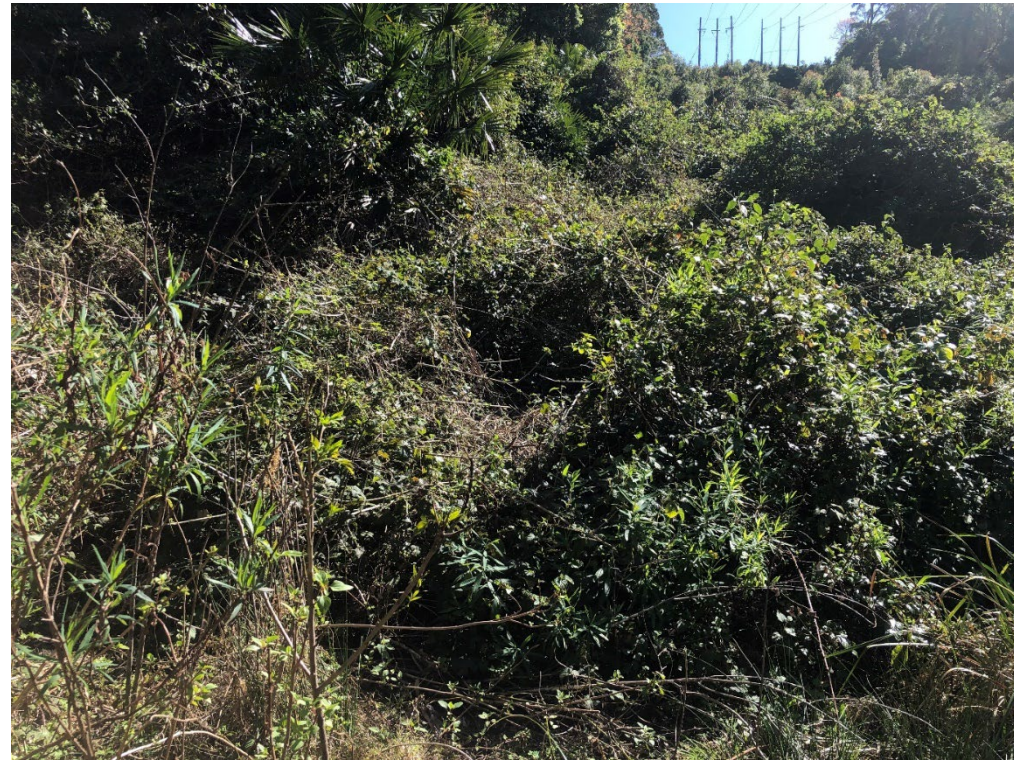
Terrain Unit 2 Photograph 1: View of section below power lines, comprised of moderate to steep slopes.

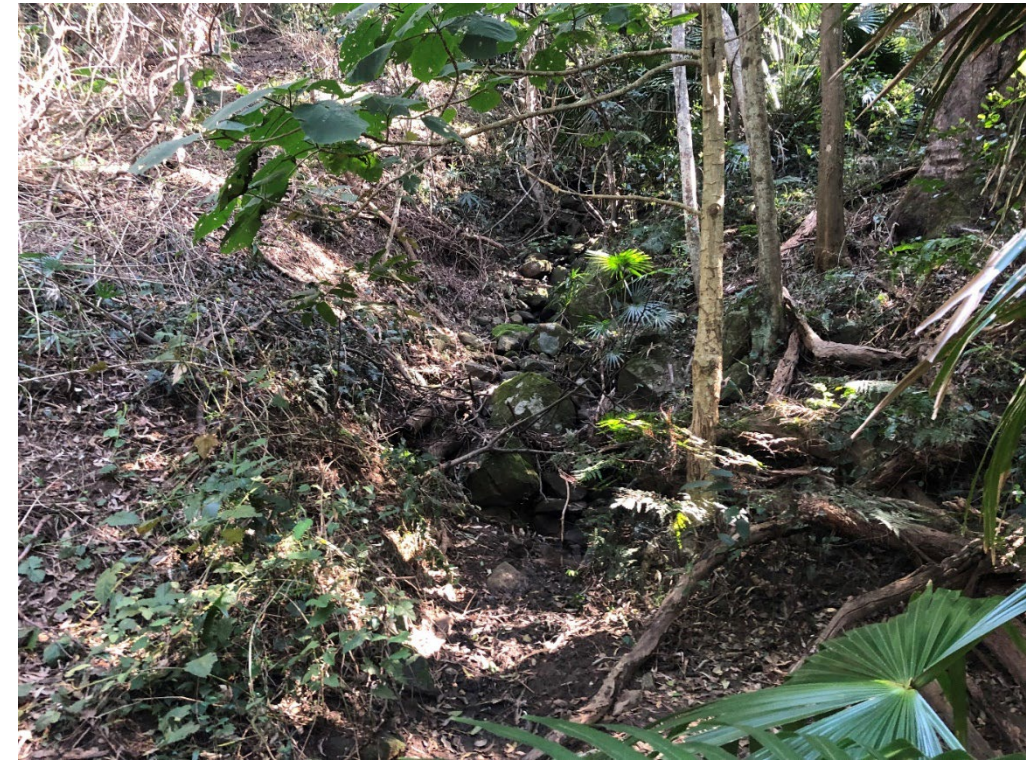
Terrain Unit 2 Photograph 2: Drainage channel along steep slopes along Trail 16.

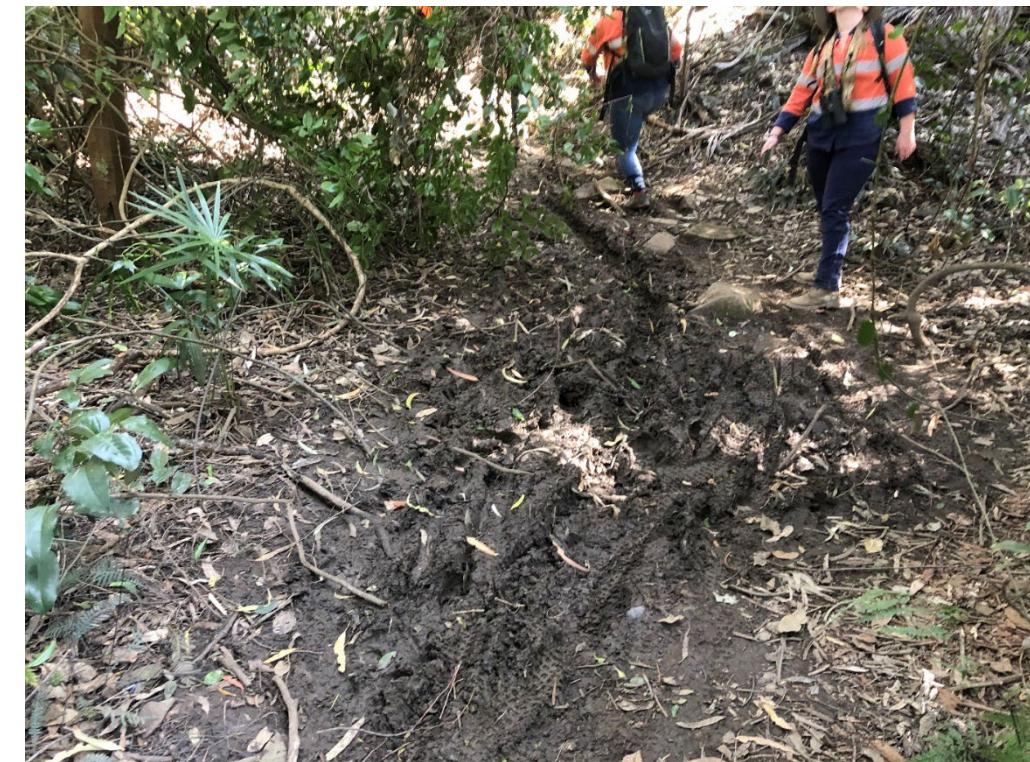
Terrain Unit 2 Photograph 4: Signs of seepage along level benches.

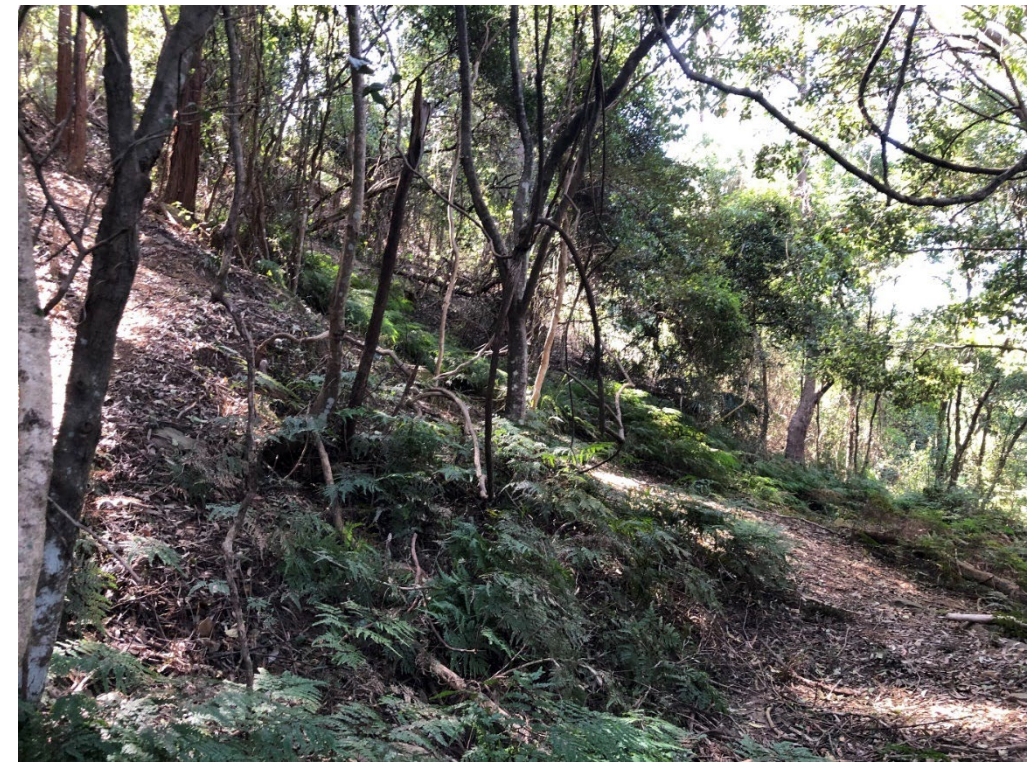
Terrain Unit 2 Photograph 6: View of steep terrain along Trail 21. Boulders visible.

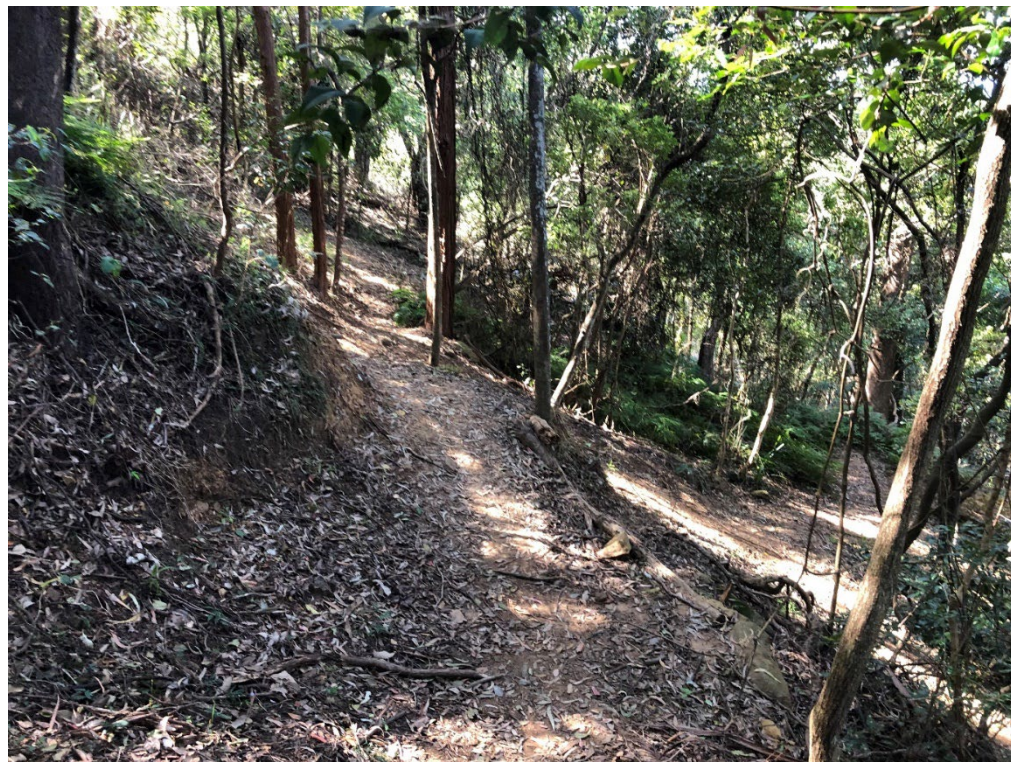
Terrain Unit 2 Photograph 7: Signs of soil creep observed along the existing trail on steep slopes along Trail 21.

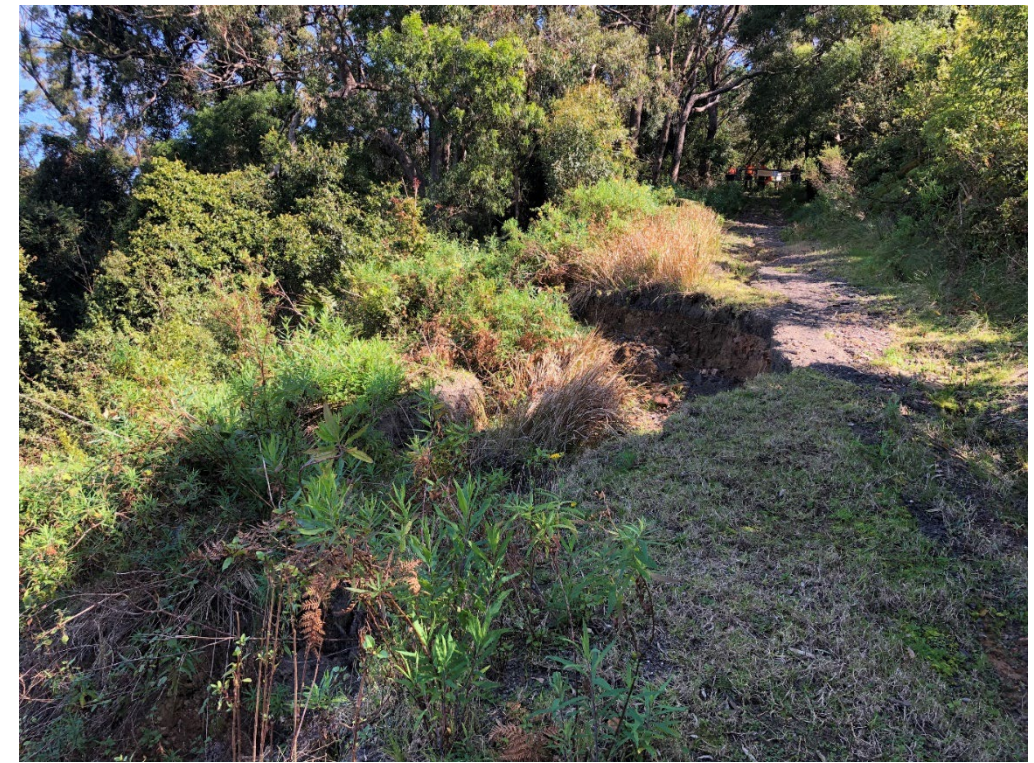
Terrain Unit 2 Photograph 8: View of slip along access road from the Corrimal Colliery.

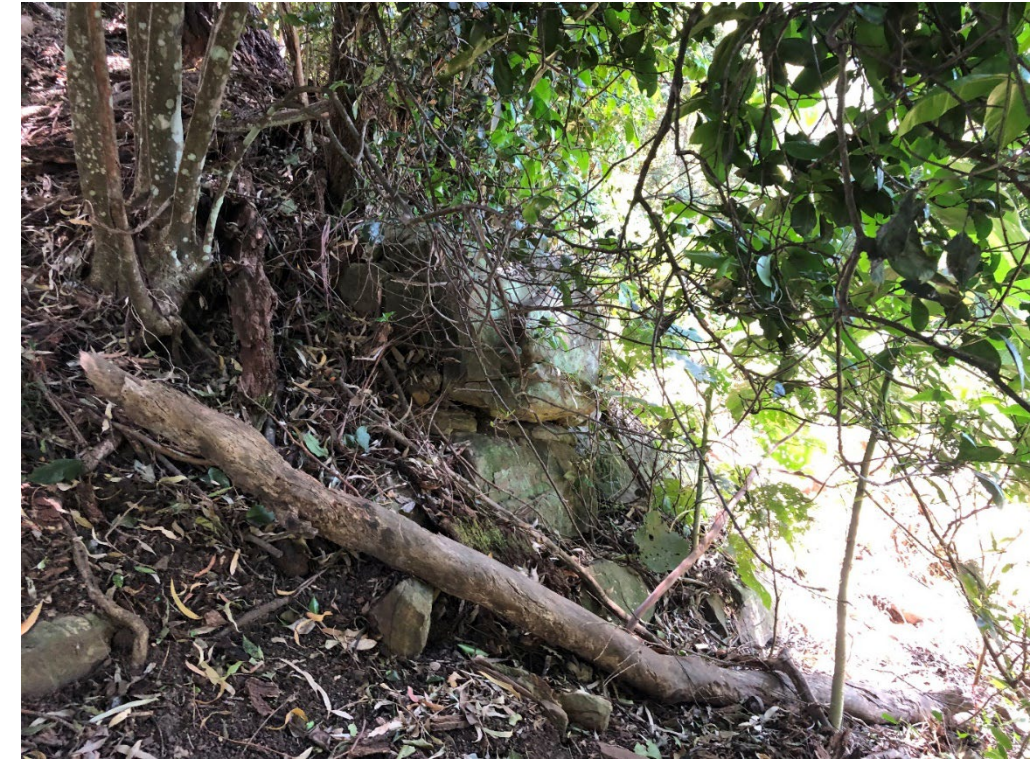
Terrain Unit 2 Photograph 10: Outcropping rock at crest of ridge near Trail 30.

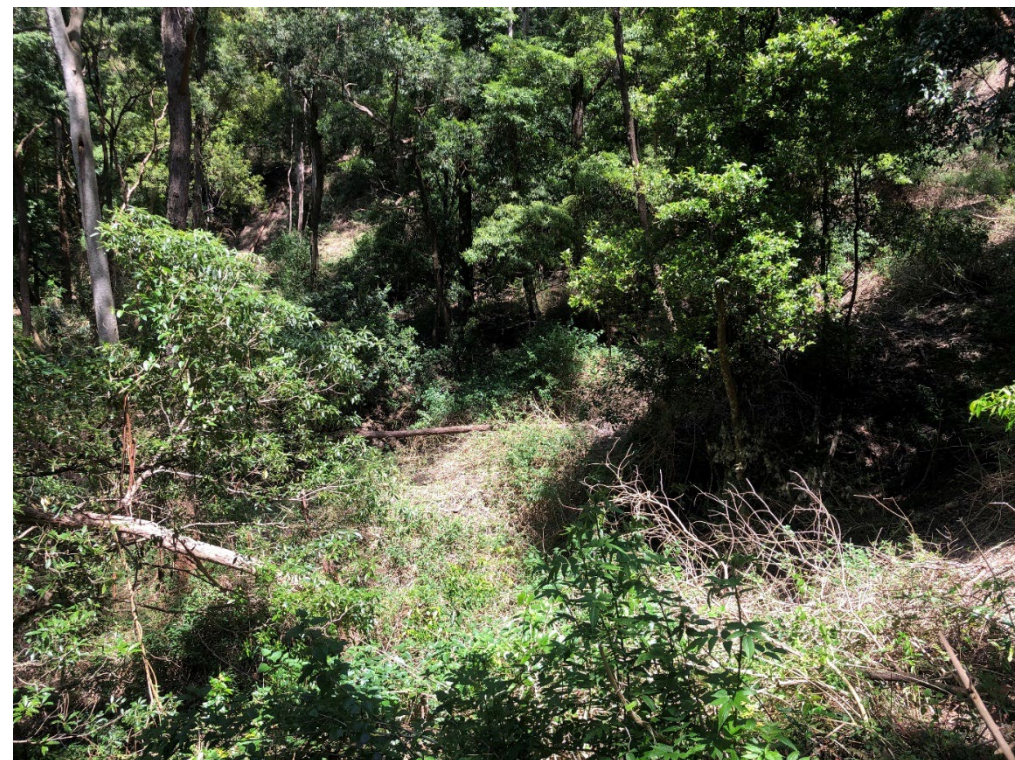
Terrain Unit 2 Photograph 11: View of gully network that Trail 31 traverses from ridge to the northeast.
