TERRA INSIGHT

Balgownie Mountain Bike Trail Network, Balgownie NSW
Report on Preliminary Geotechnical Assessment

Our Ref: TERRA22-223.Rep1.Rev1

4 April 2023

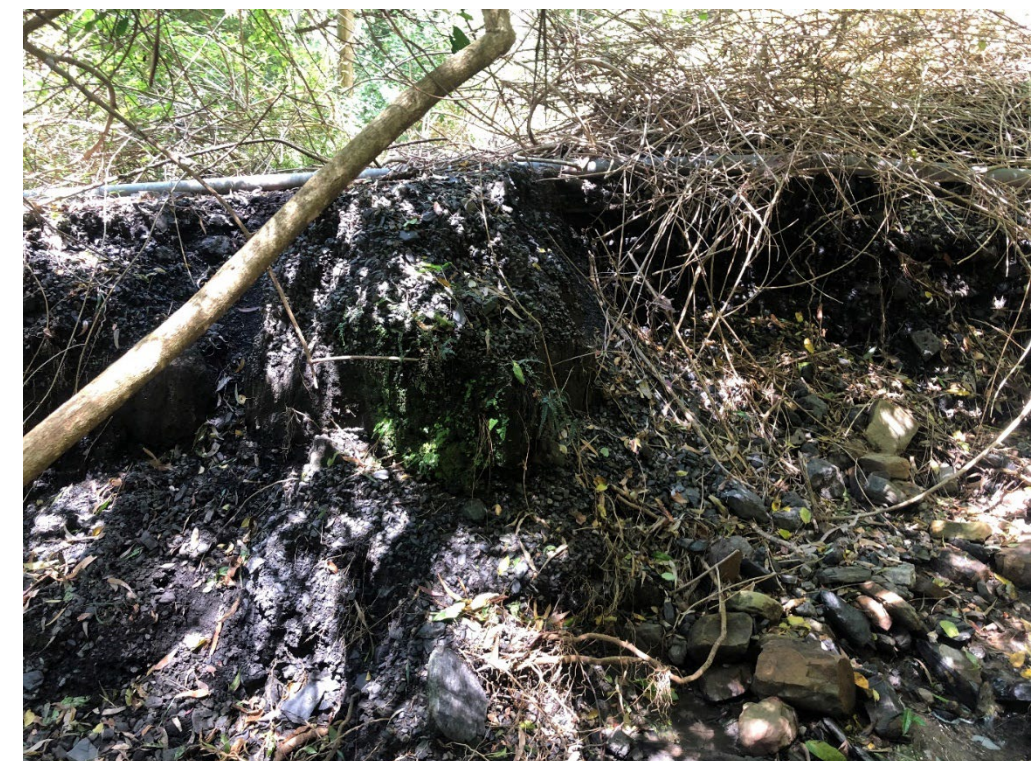
Terrain Unit 2 Photograph 12: View of coalwash like fill in the base of the gully network.

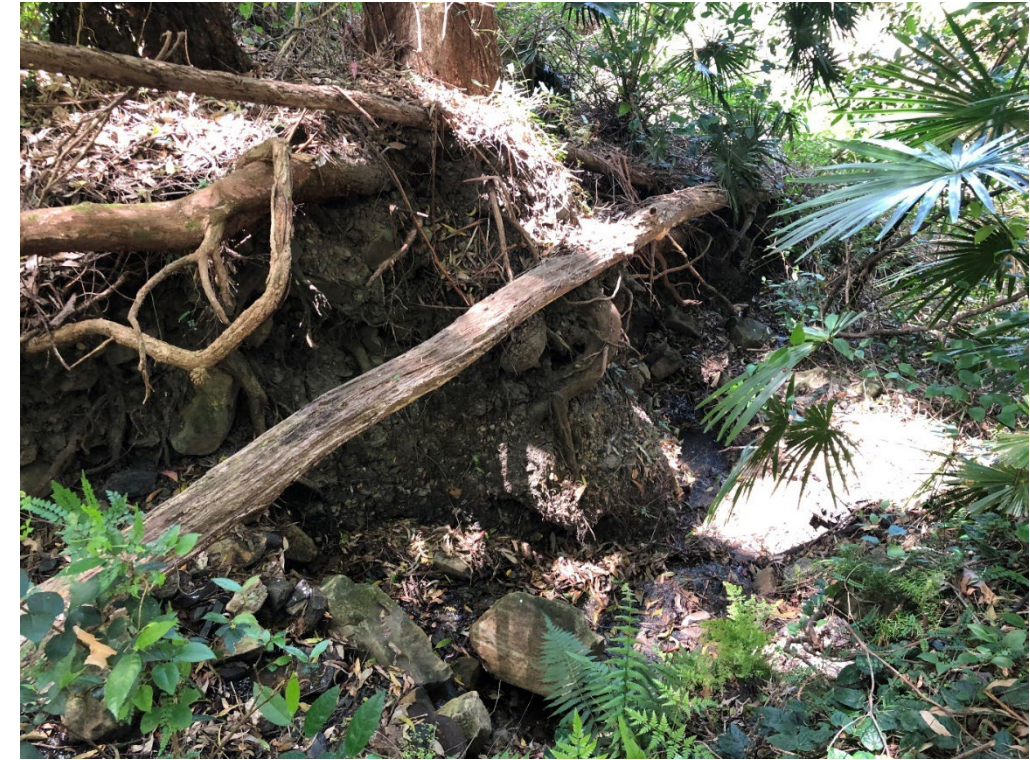
Terrain Unit 2 Photograph 14: Deep incised channels formed within the fill.

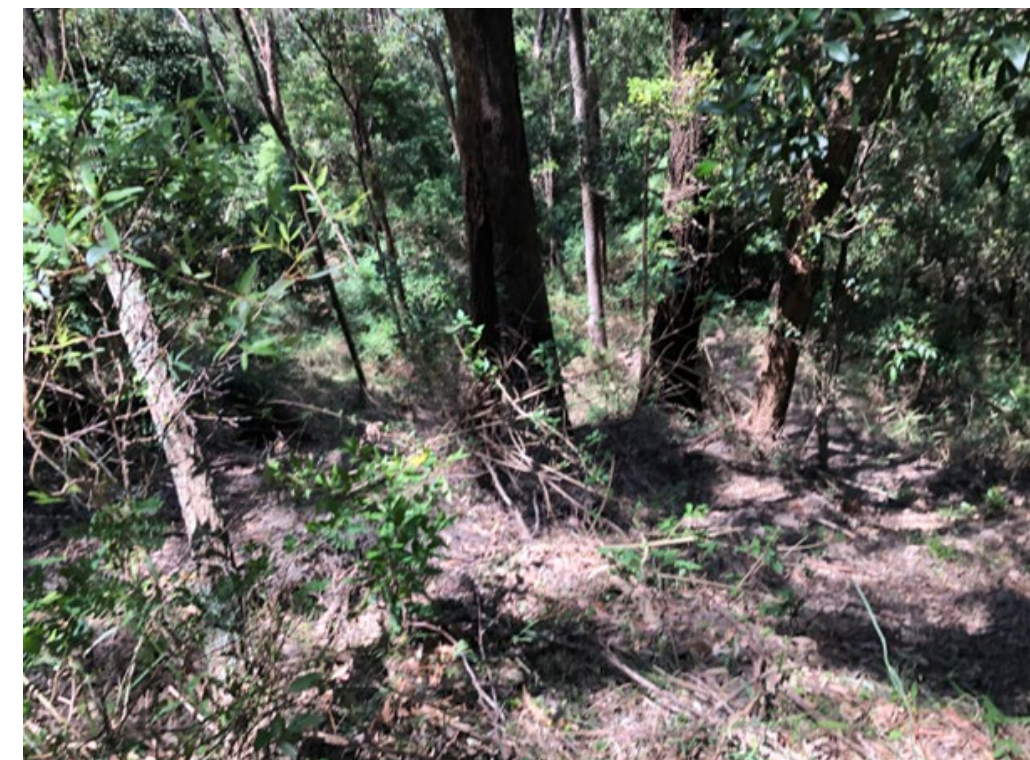
Terrain Unit 2 Photograph 16: View of slip upslope of Trail 31.

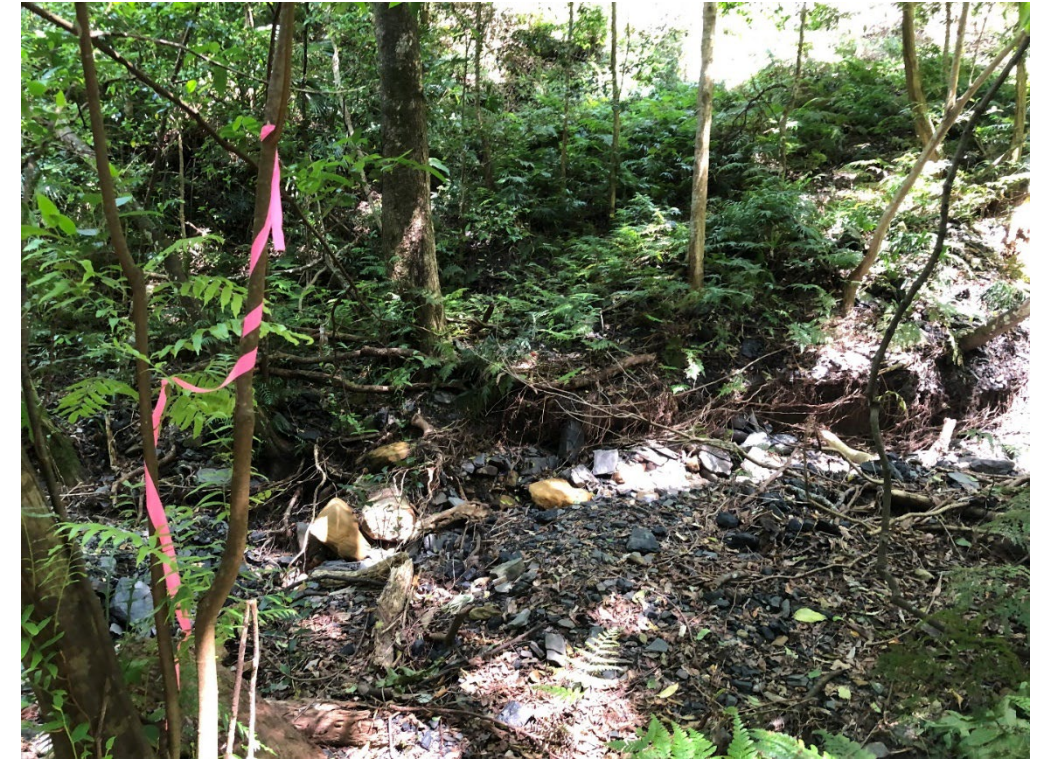
Terrain Unit 2 Photograph 18: View of Trail 32 and 33 bridge intersection.

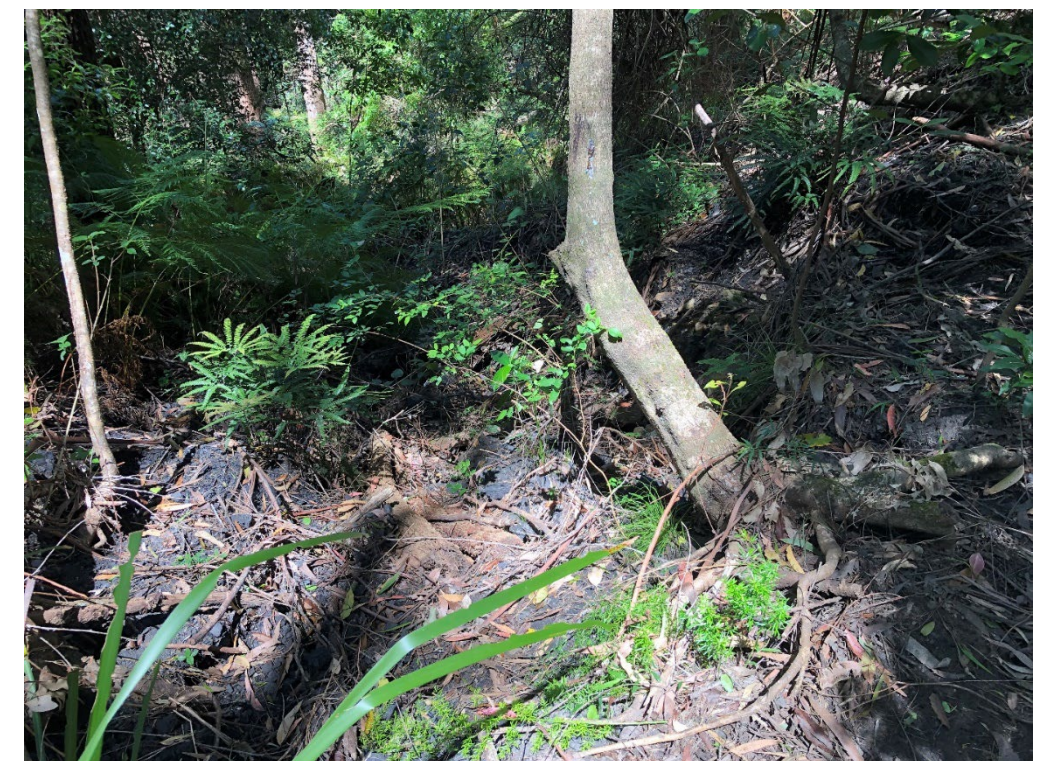
Terrain Unit 2 Photograph 20: Material and some washout along crest of filled side of Old Train Line.

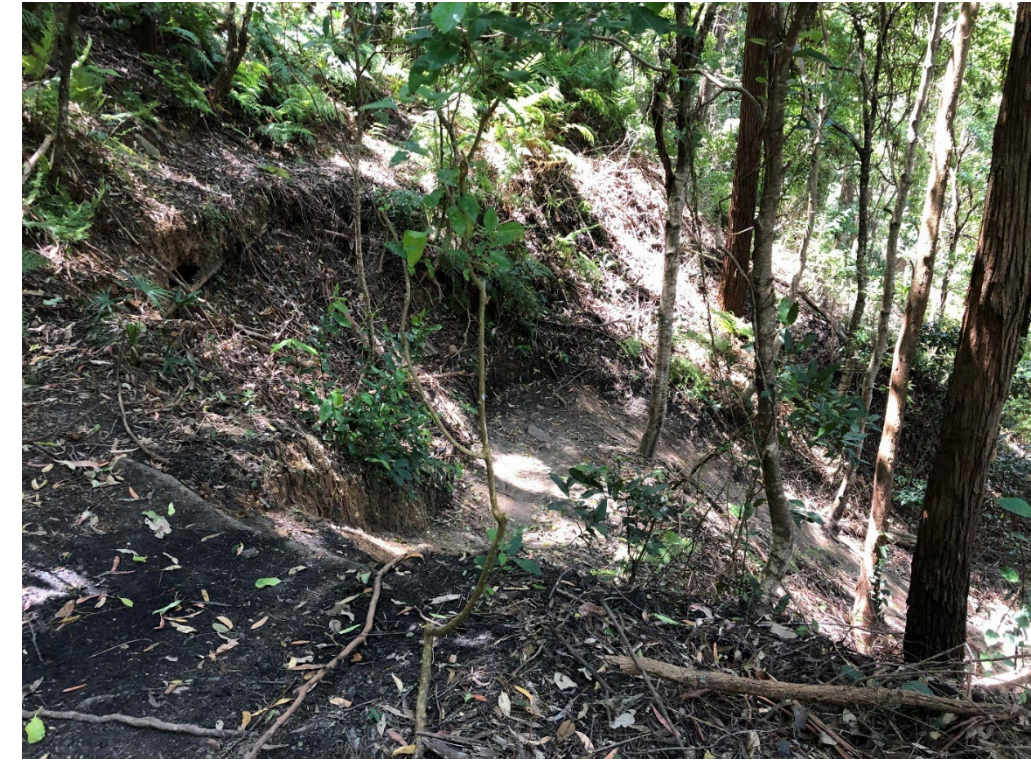
Terrain Unit 2 Photograph 22: View of old slip across filled section of Old Train Line along Trail 28.

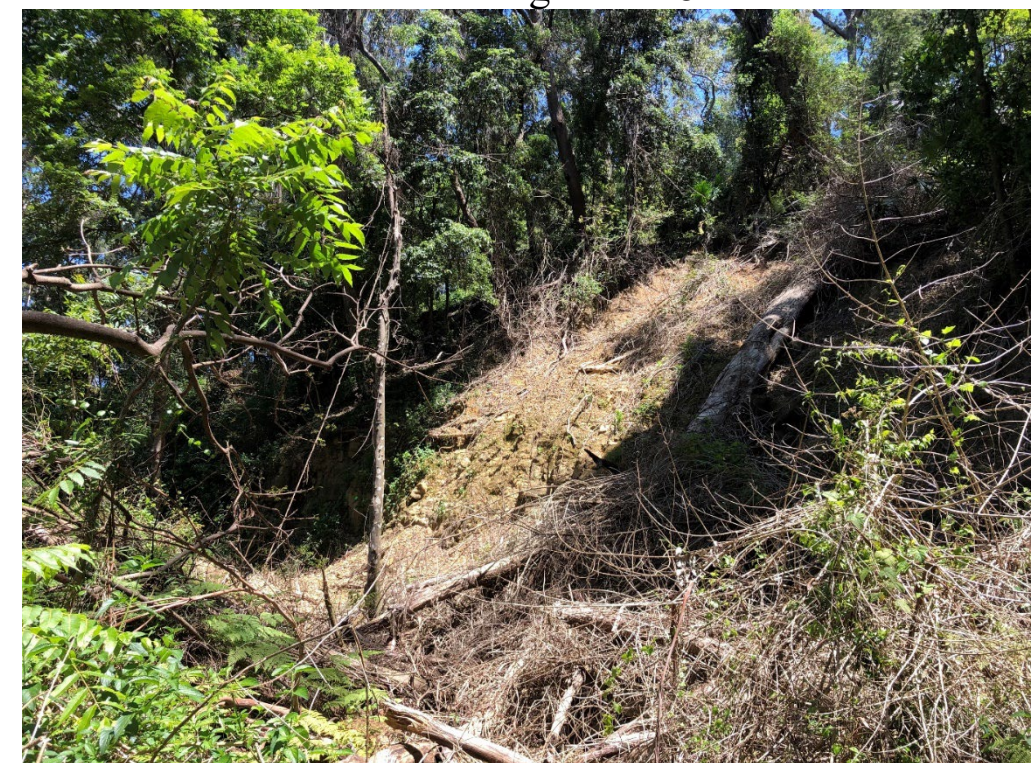
present on the slip. Rock outcrops are observed above the Old Train Line, washout and slips have occurred along the overburden soils as shown in Photograph 23 and 24. Impact from these slips are manageable.	
--	--	--

Terrain Unit 2 Photograph 24: View of overburden soil washout.

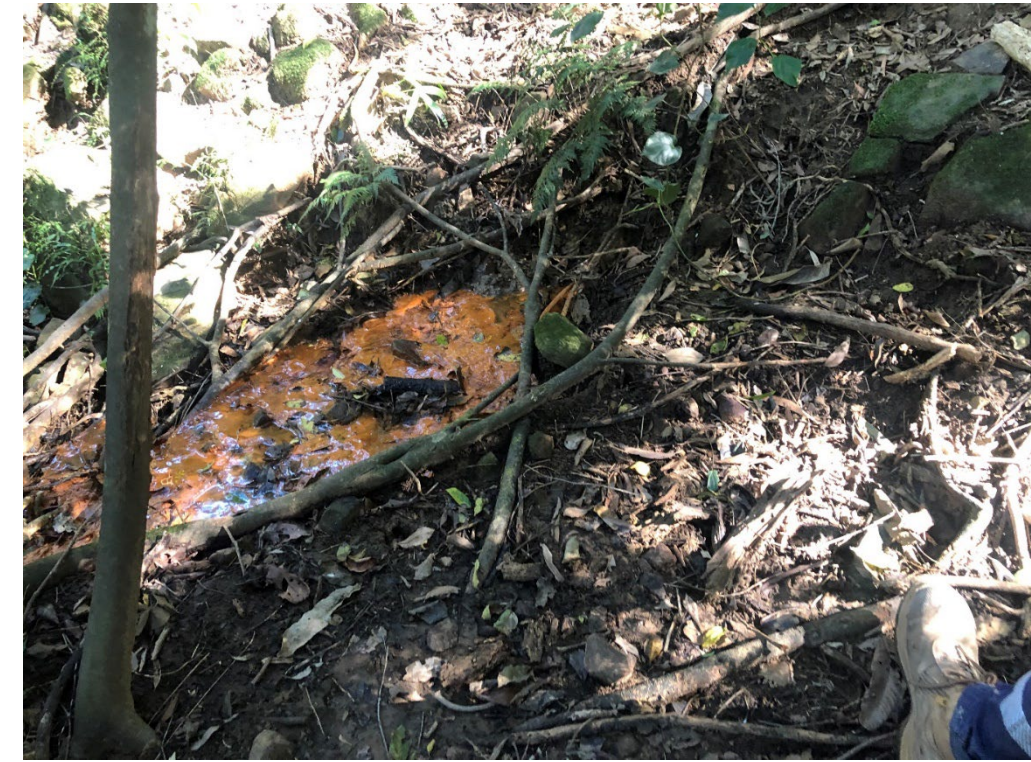
Terrain Unit 3 Photograph 2: Seepage along the level terrain along the toe of the steep bench slopes.

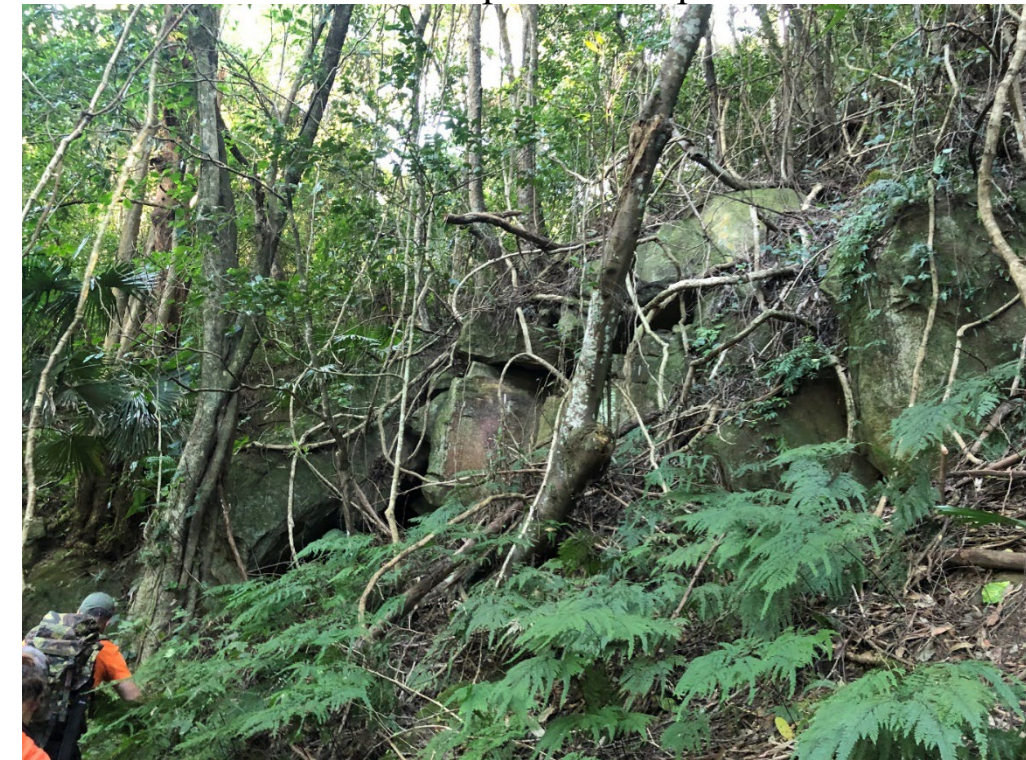
Terrain Unit 3 Photograph 4: Outcropping rock above Trail 21 and 22

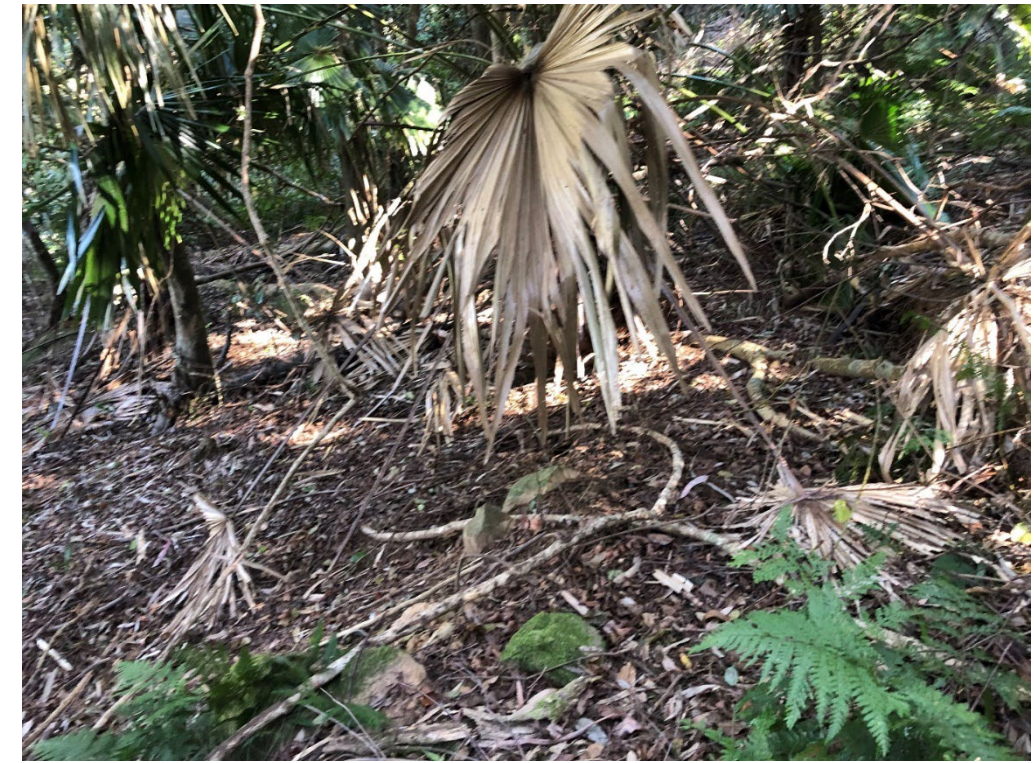
Terrain Unit 3 Photograph 6: Tension cracks progressing along the crest of the bench.

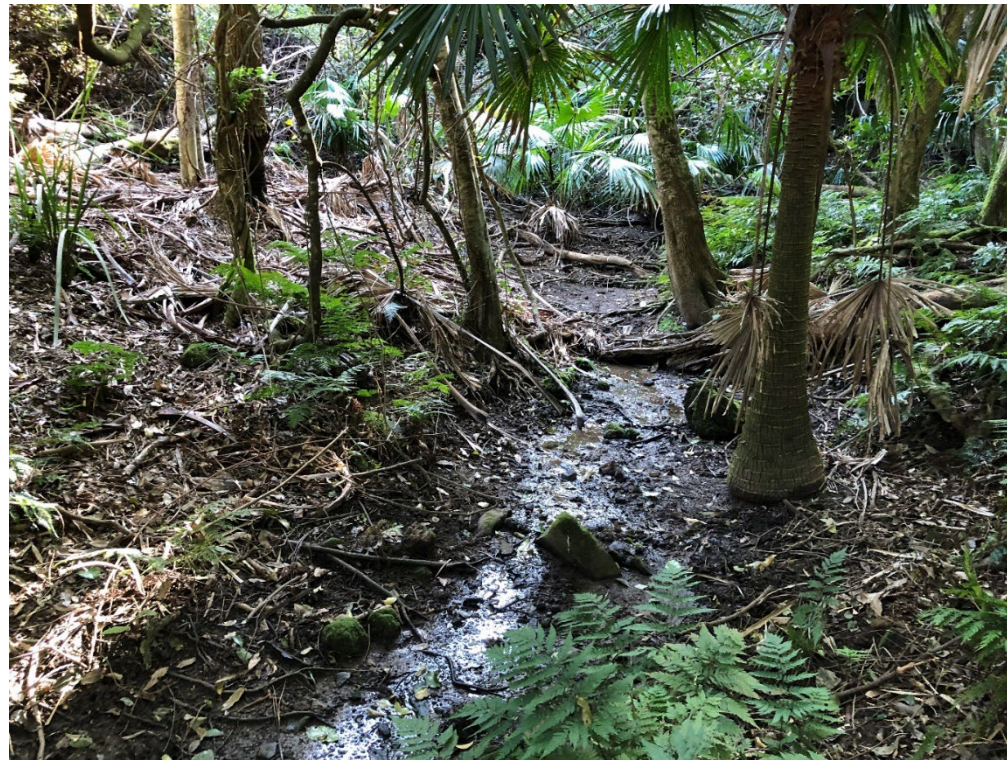
Terrain Unit 3 Photograph 7: Minor channel along Trail 22 along the level terrain.

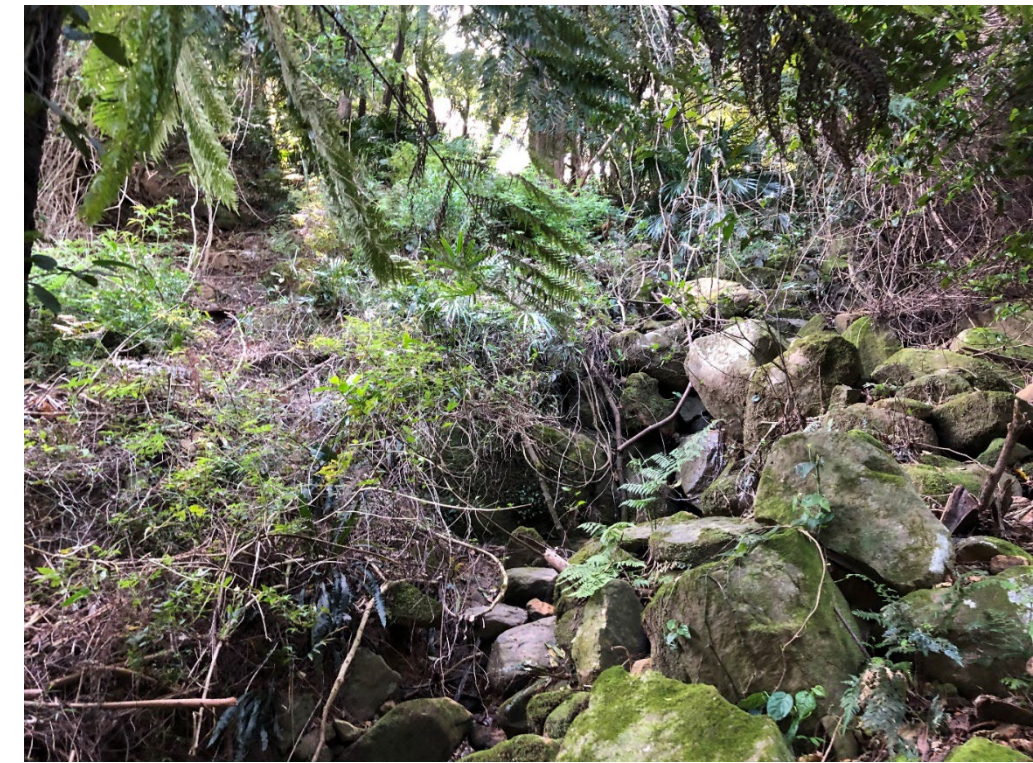
Terrain Unit 3 Photograph 8: View where Trail 24 traverses down a very steep bench slope (left) with adjacent drainage channel to the (right).

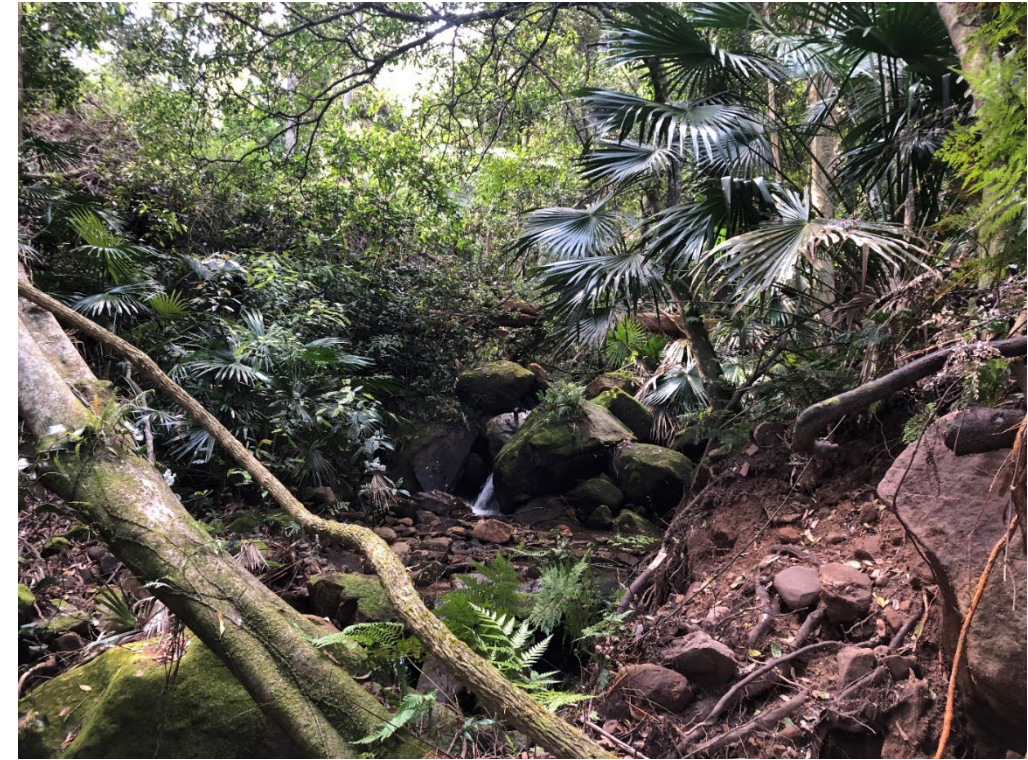
Terrain Unit 3 Photograph 10: Deeply incised channel full of boulders that Trail 24 crosses.

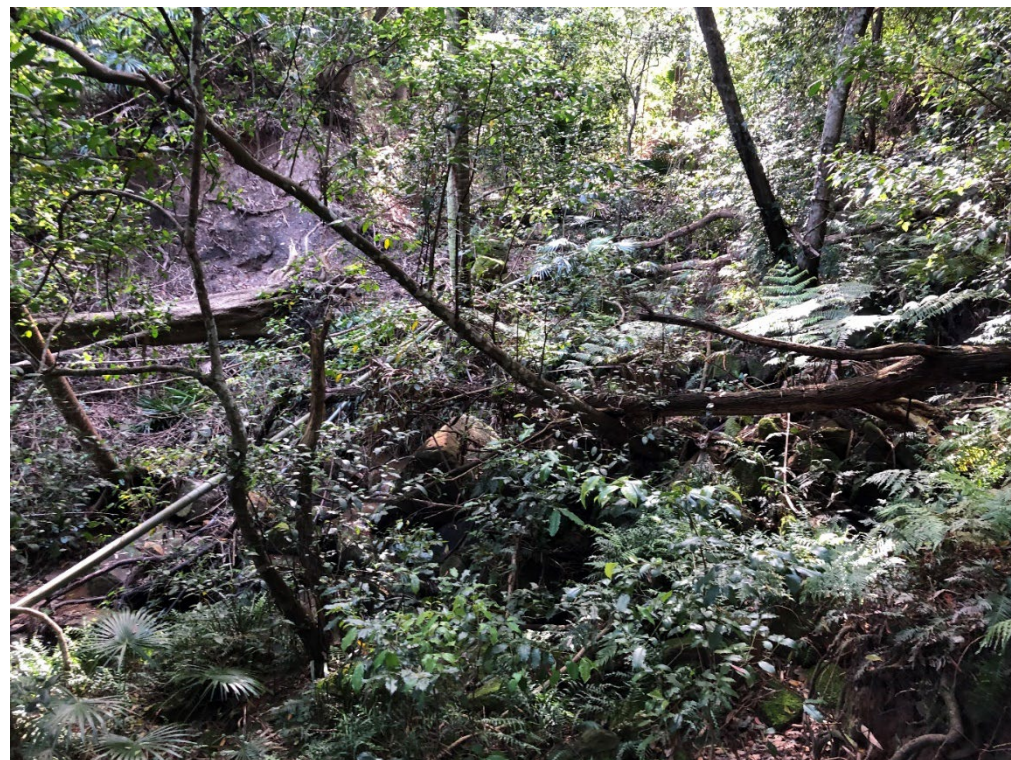
Terrain Unit 3 Photograph 11: Bank instability observed along the channel banks near Trail 24 crossing.

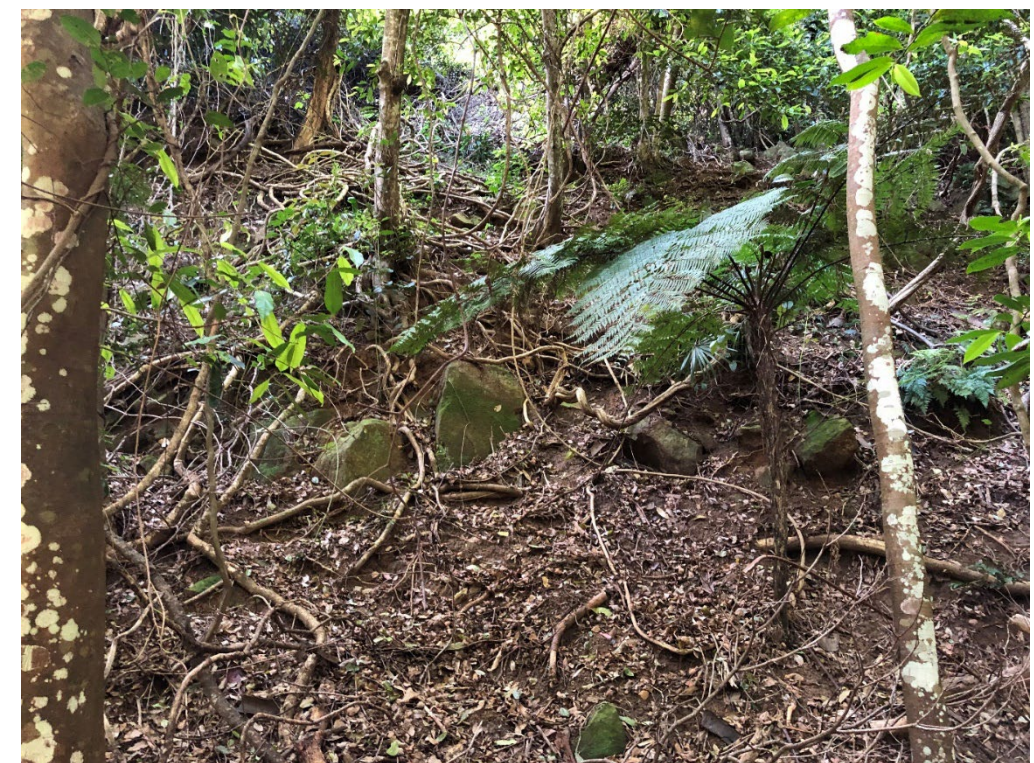
Terrain Unit 3 Photograph 12: Outcropping rock in the location of Trail 25a.

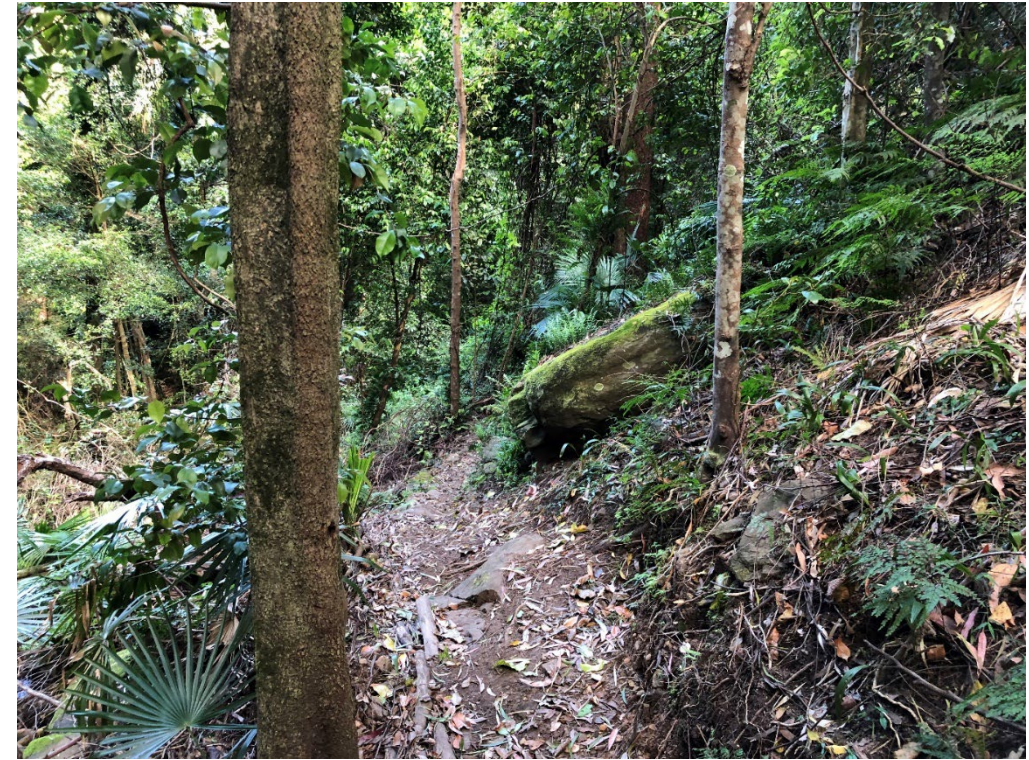
Terrain Unit 3 Photograph 14: View of Trail 33 as it continues down the very steeply sloping bench.

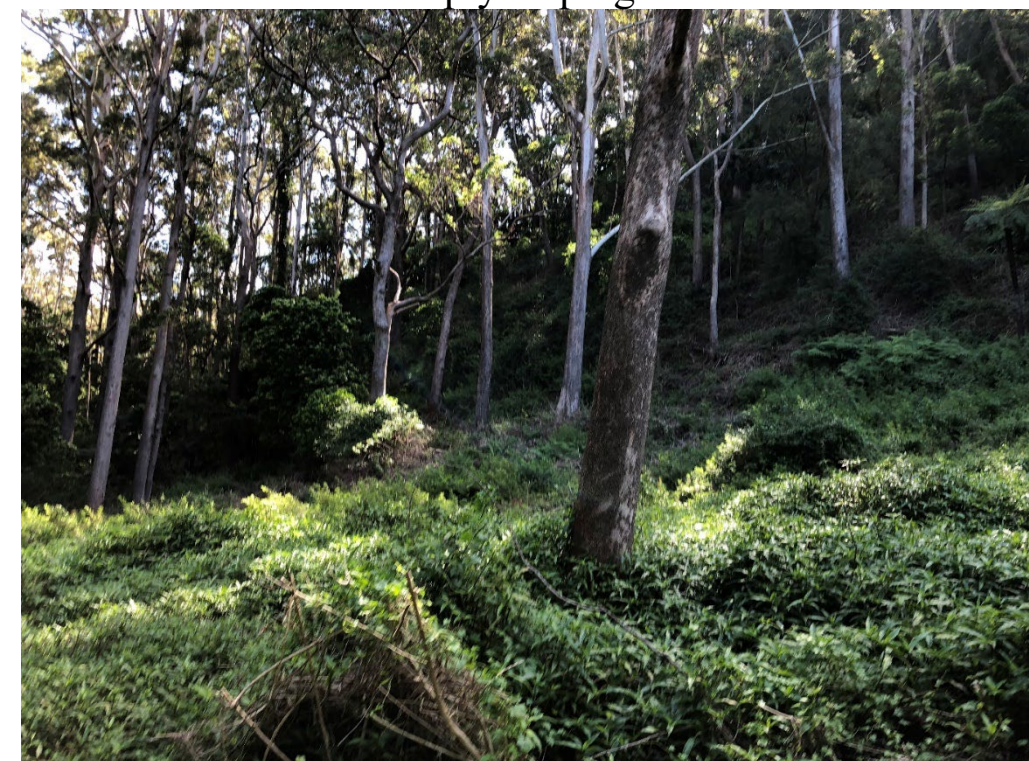
Terrain Unit 4 Photograph 16: View of Terrain Unit 4 slopes from the Upper access road.

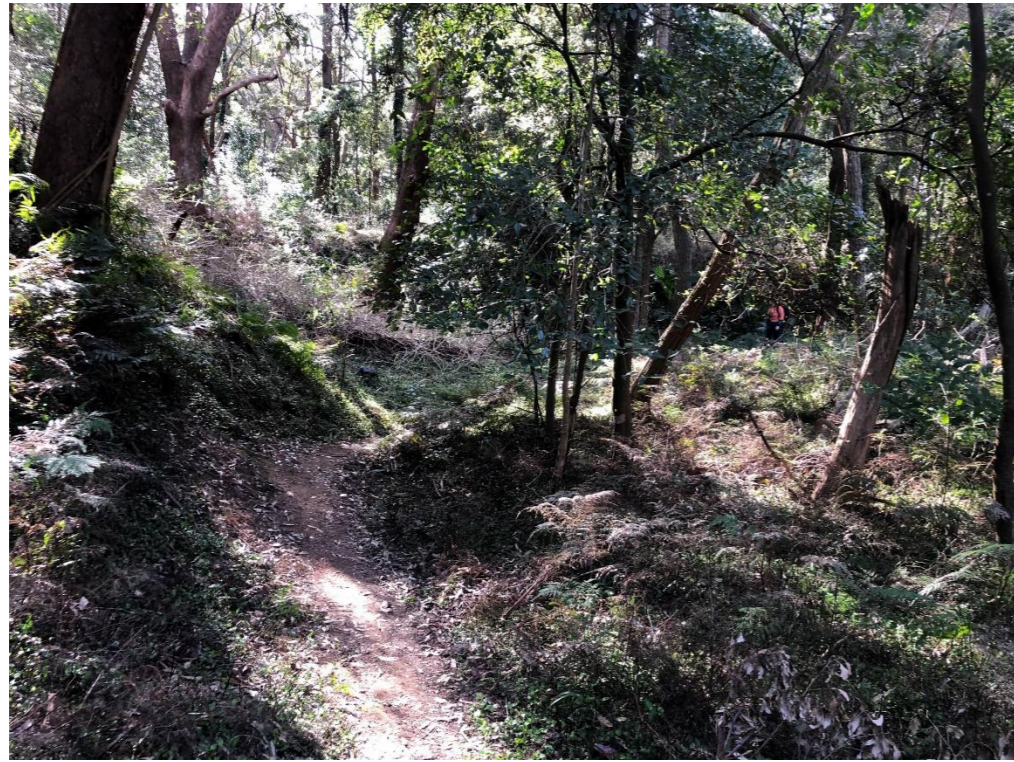
Terrain Unit 5 Photograph 1: View of soil creep on very steep slopes away from the drainage channel.

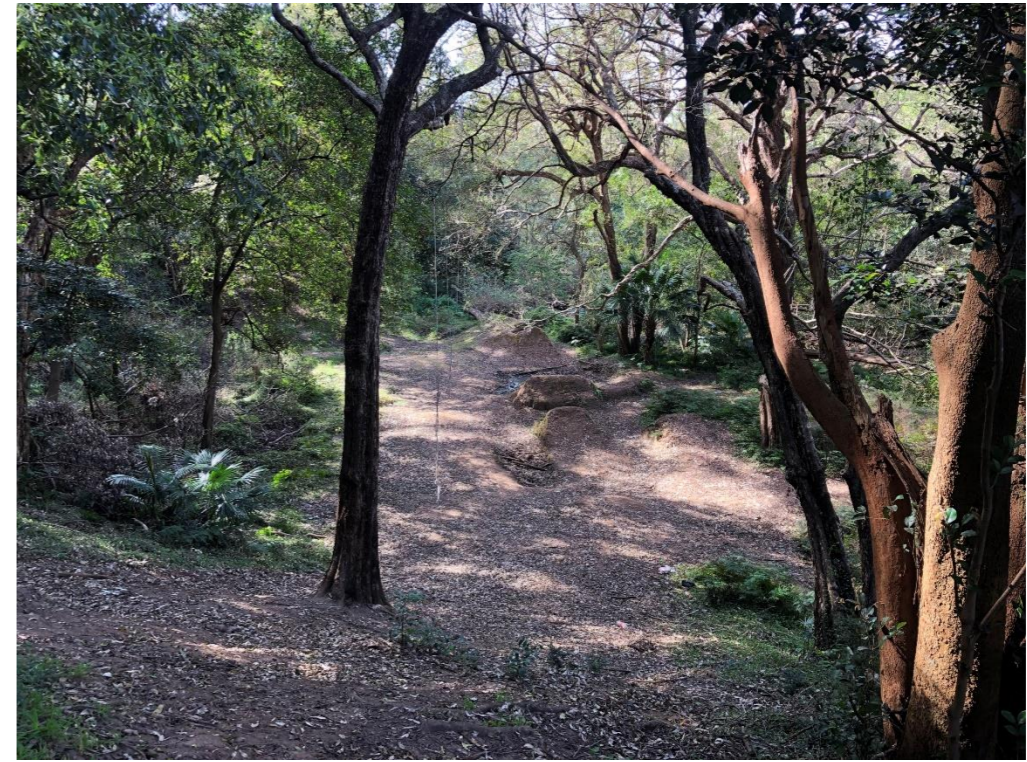
Terrain Unit 5 Photograph 2: View of steep slopes to level base of alluvial terrain.

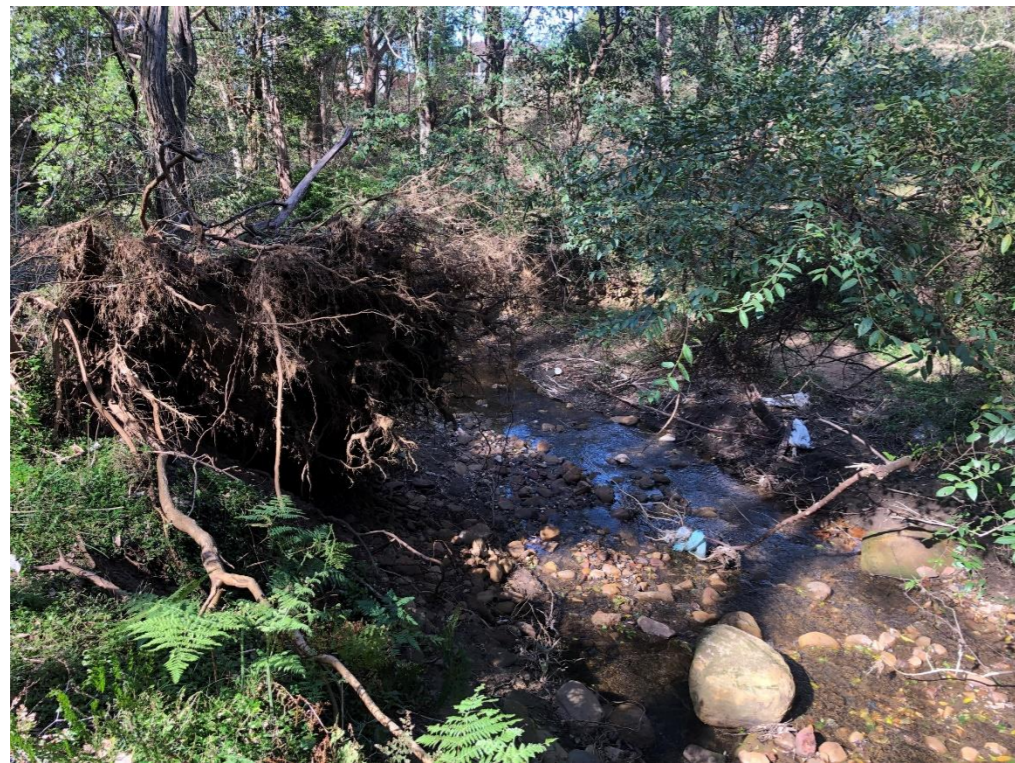
Terrain Unit 5 Photograph 3: View of increased erosion along the active river channel.

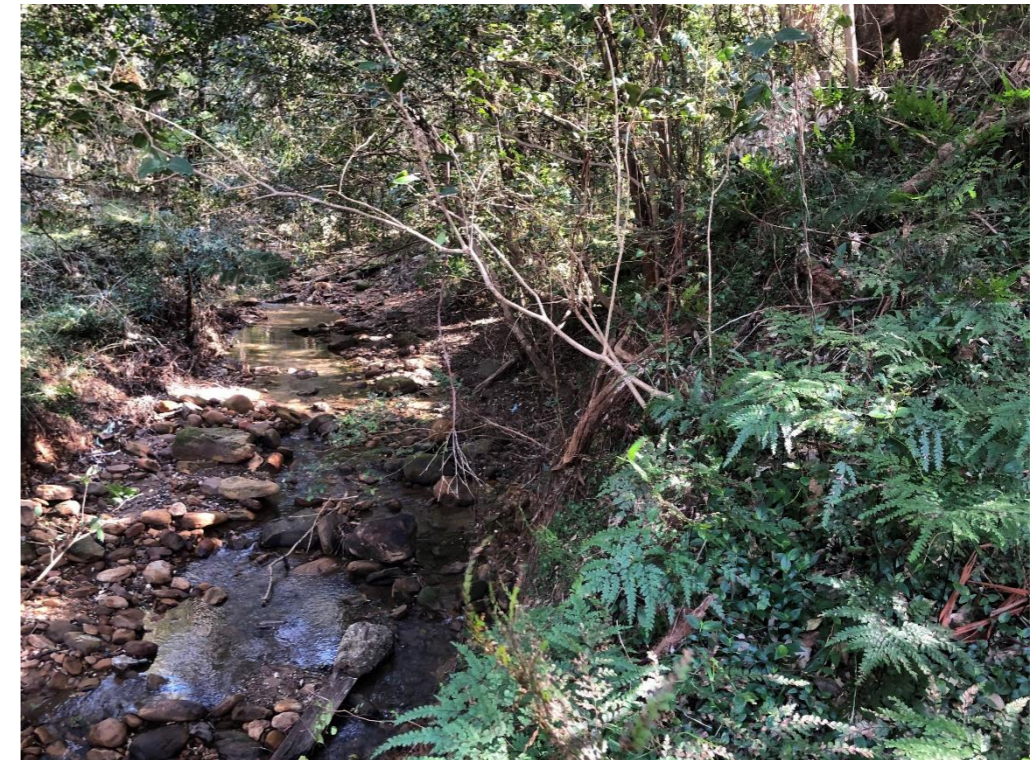
Terrain Unit 5 Photograph 4: View of very steep slopes along the active river channel.

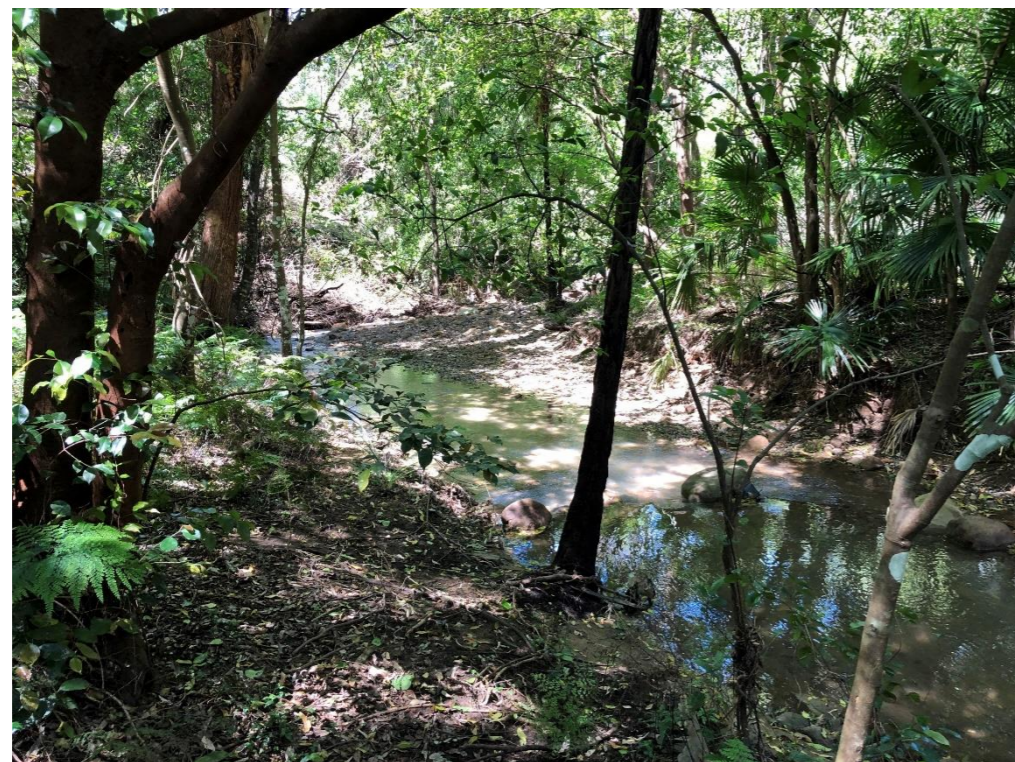
Terrain Unit 5 Photograph 7: Trail 1 Bridge Location looking southeast.

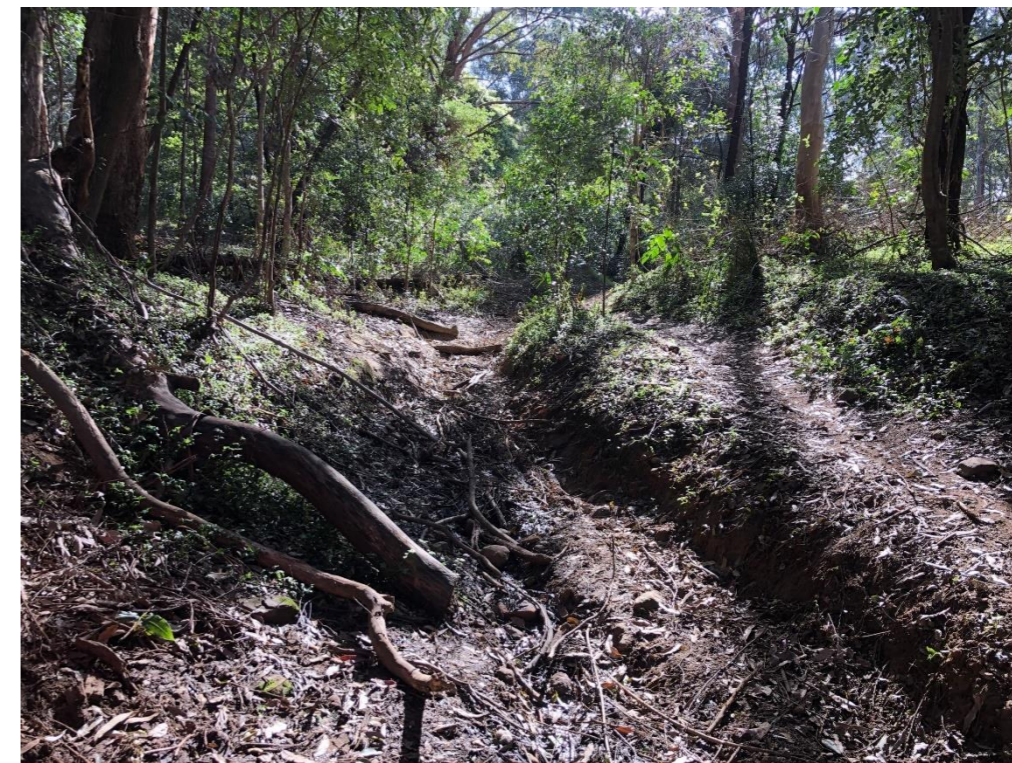
Terrain Unit 5 Photograph 8: Erosion along trails into Terrain Unit 5.
