**Sustainable Development Plan**

# **Grout Remediation Plan**

**West Wallsend Colliery**

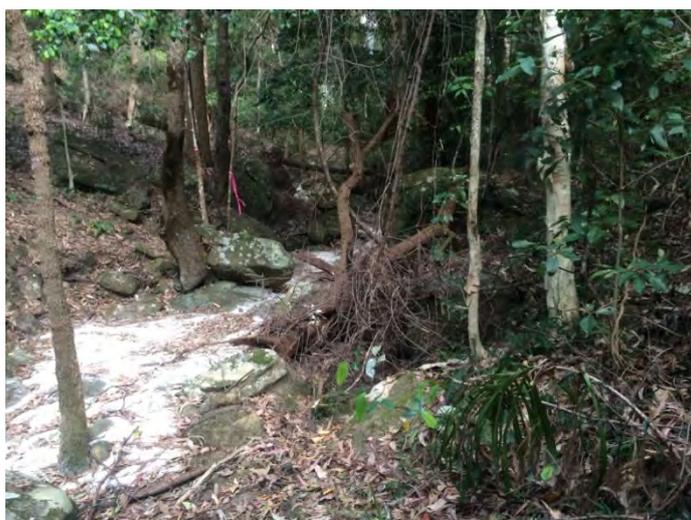
**Photo 1** - Pre Remediation Photo Section 1 monitoring point (3 October 2013)

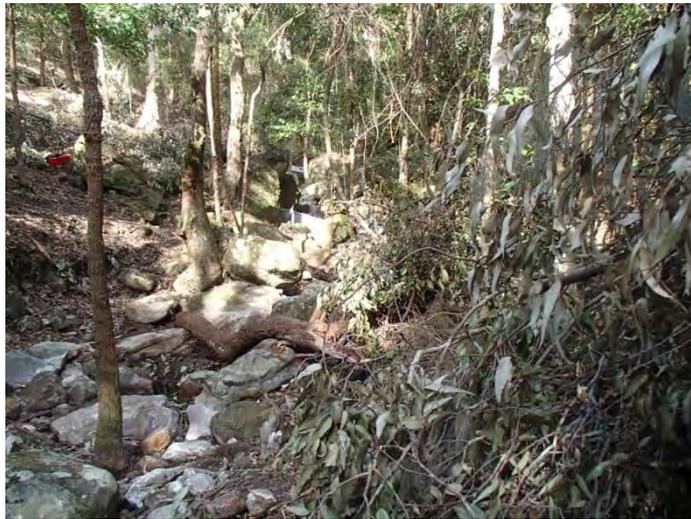
**Photo 2** - Post Remediation Photo Section 1 monitoring point (4 December 2013)
