Towards safer swimming – Terrigal region

Terrigal Bay, Terrigal Lagoon and Avoca Lagoon
stormwater catchment audit

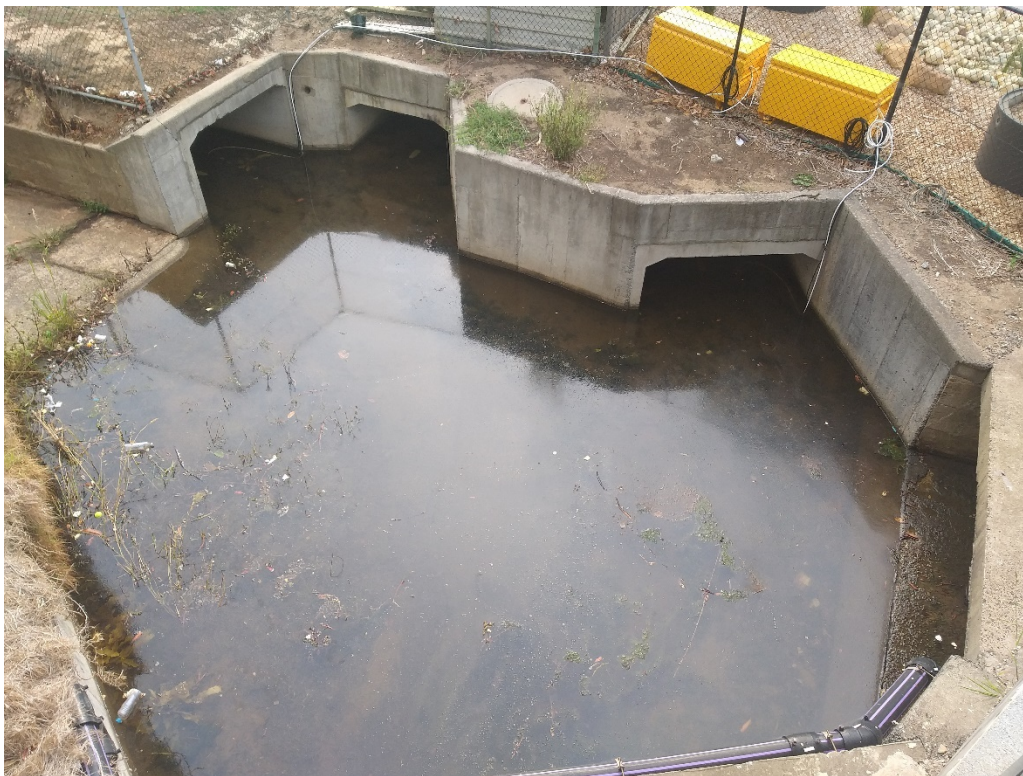
Autosamplers at Terrigal, upstream on seven drains. Photo: DPIE

From November 2019, flow loggers (Sontek IQ, Xylem Inc.) were installed on the three incoming branches at the stormwater junction adjacent to the sewer pump station at Ash Street, the largest stormwater sub-catchment in Terrigal Bay draining about 53% of the land area of Terrigal CBD and the Haven (Figure 2B). Flow loggers in the two major arms (TSD and TBD2) at this junction were run in tandem with automated water samplers (SCU Smart Auto Sampler) that collected discrete water samples each time drain water level changed by 2 centimetres throughout a rainfall event. The autosamplers are equipped to keep enterococci samples chilled until collection. Flow loggers and autosamplers were installed in January 2020 and were operational during wet weather events on 18 January and 7 February 2020.

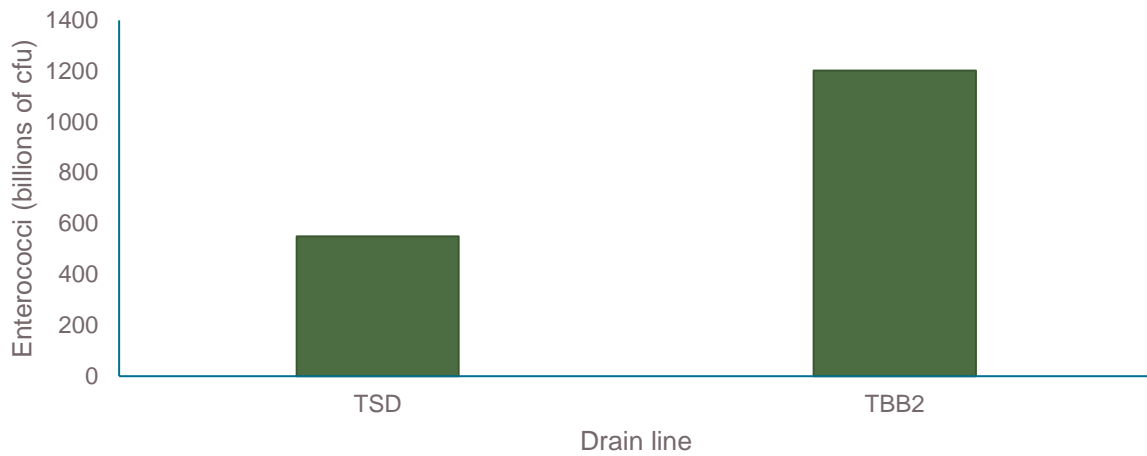
During the 18 January 2020 wet weather event (Figure 1), when simultaneous data from both stormwater network TSD and TBB2 branches (Figure 2) were available, there was no relationship between enterococci concentration and flow rate (Figure 8a) in the dominant (in terms of flow) southern branch (TSD), while in the north-west branch (TBD2), enterococci concentration was significantly correlated with flow rate ($p < 0.04$) (Figure 8b). For this event, despite the TSD branch having higher flow, the TBD2 branch contributed a higher enterococci load to Terrigal Bay (Figure 9).

Figure 9 Total enterococci loads for the major branches of Terrigal Bay's stormwater catchment during wet weather on 18 January 2020
