TERRA INSIGHT

Balgownie Mountain Bike Trail Network, Balgownie NSW
Report on Preliminary Geotechnical Assessment

Our Ref: TERRA22-223.Rep1.Rev1

4 April 2023

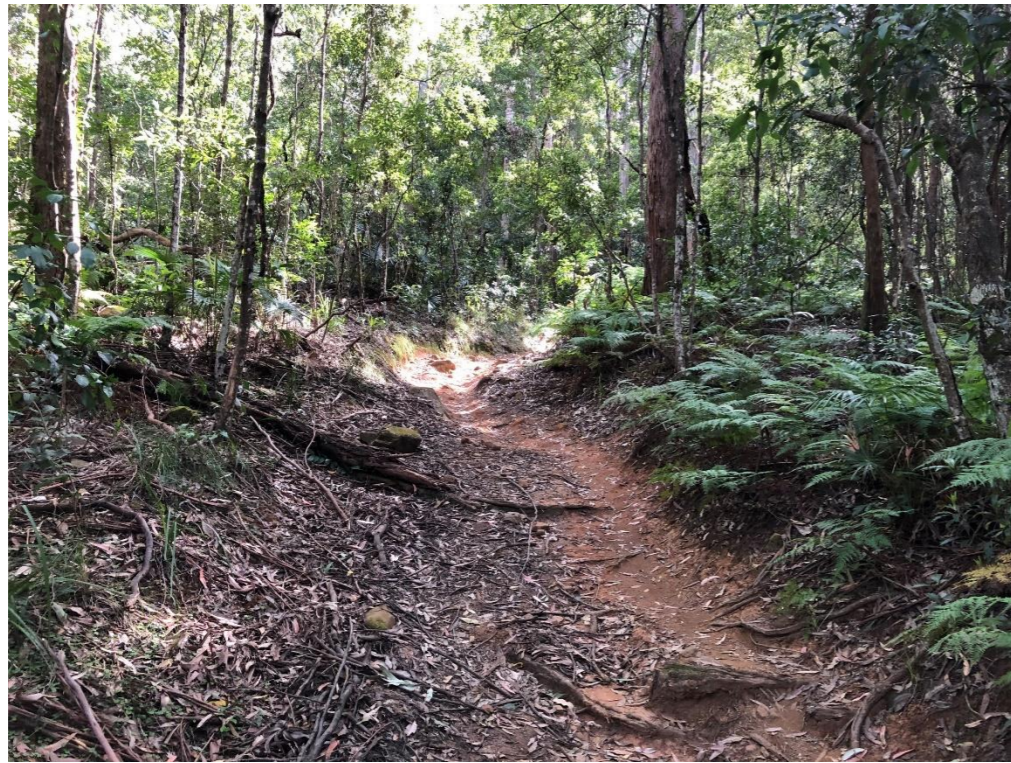
Terrain Unit 1 Photograph 5: Erosion along trail above Trail 12.

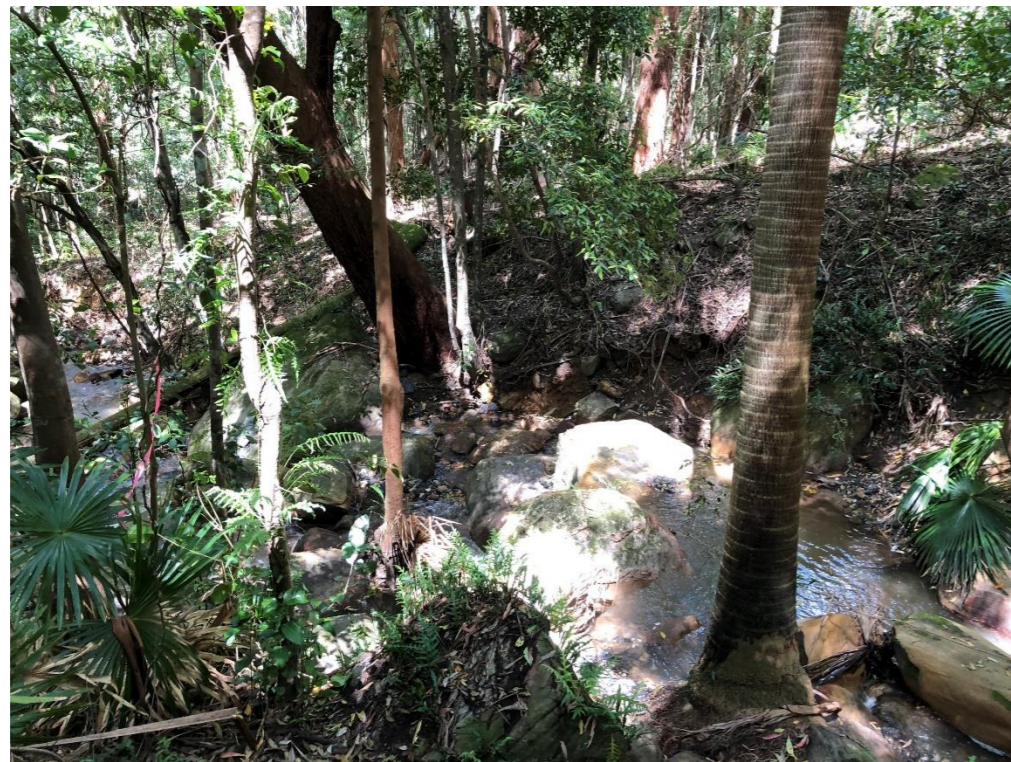
Terrain Unit 1 Photograph 7: View of proposed crossing in location of Trail 15, 16 and 18 junction.

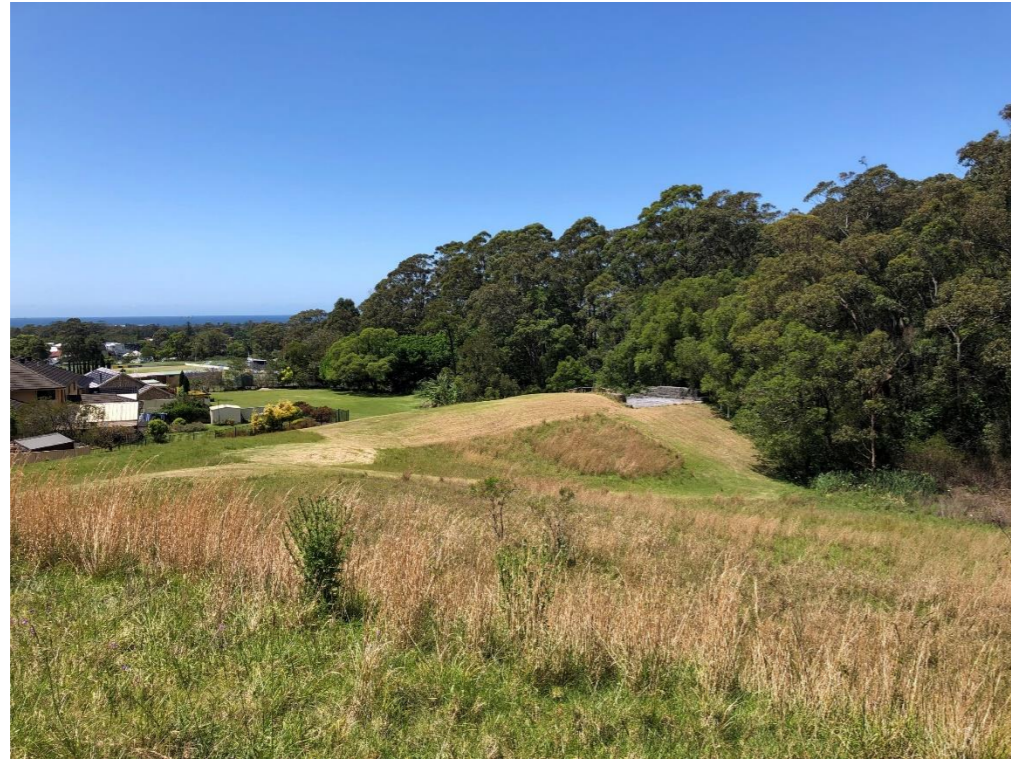
Terrain Unit 1 Photograph 9: Slopes at the toe of T1, NE.

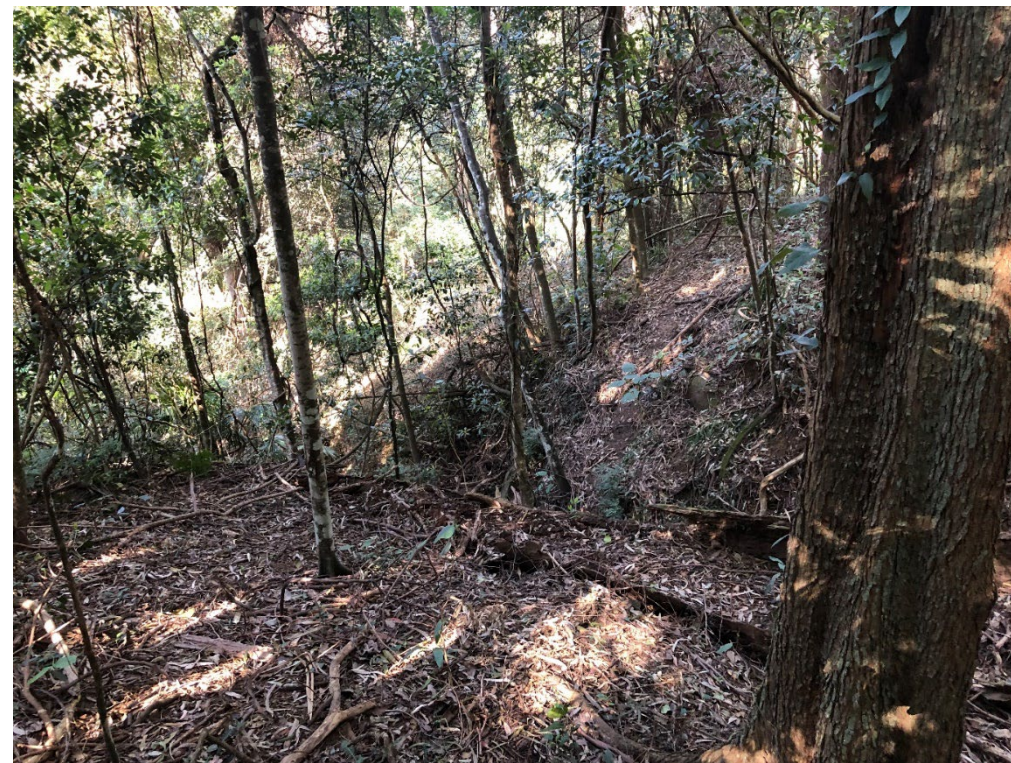
Terrain Unit 2 Photograph 3: View of drainage channel continuing over poorly defined bench along Trail 16.

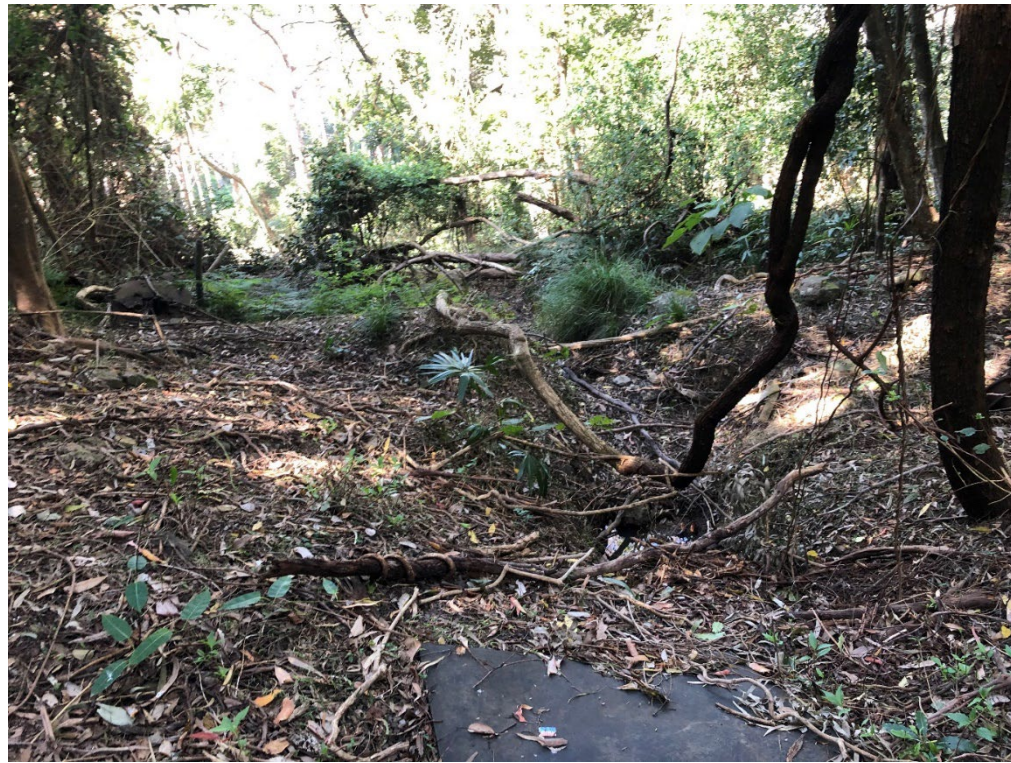
Terrain Unit 2 Photograph 5: View of level bench below steep section along Trail 21. Boulders visible

- AOC3 and AOC4 – In AOC3 Trail 21 follows the toe of the very steep slopes with rock outcrops. The steep section of the slope is about 20m high and averages about 30 to 40 degrees. It is recommended that Trail 21 is moved at least 10m to 15m downslope, so it is on level terrain away from the slope. For AOC3 and AOC4, where the trail traverses up the slope, any loose boulders that can impact the trail are to be removed, boulders that cannot be removed and jointed rock within the outcrop are to be stabilised with rock bolts or similar. The trail is to comprise of a full bench and should have rockfall hazard warning signage along the trail. Surface water can be trained to flow away from these section using swales into natural gullies.

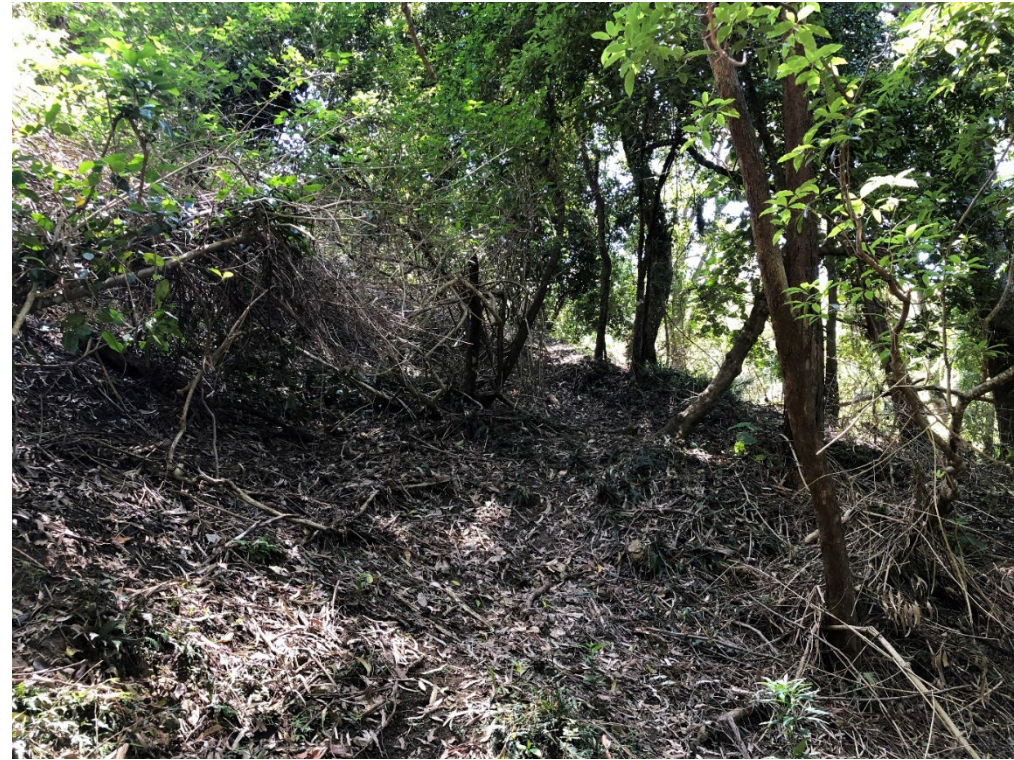
Terrain Unit 2 Photograph 9: Steep ridge along Trail 30, with signs of soil creep.

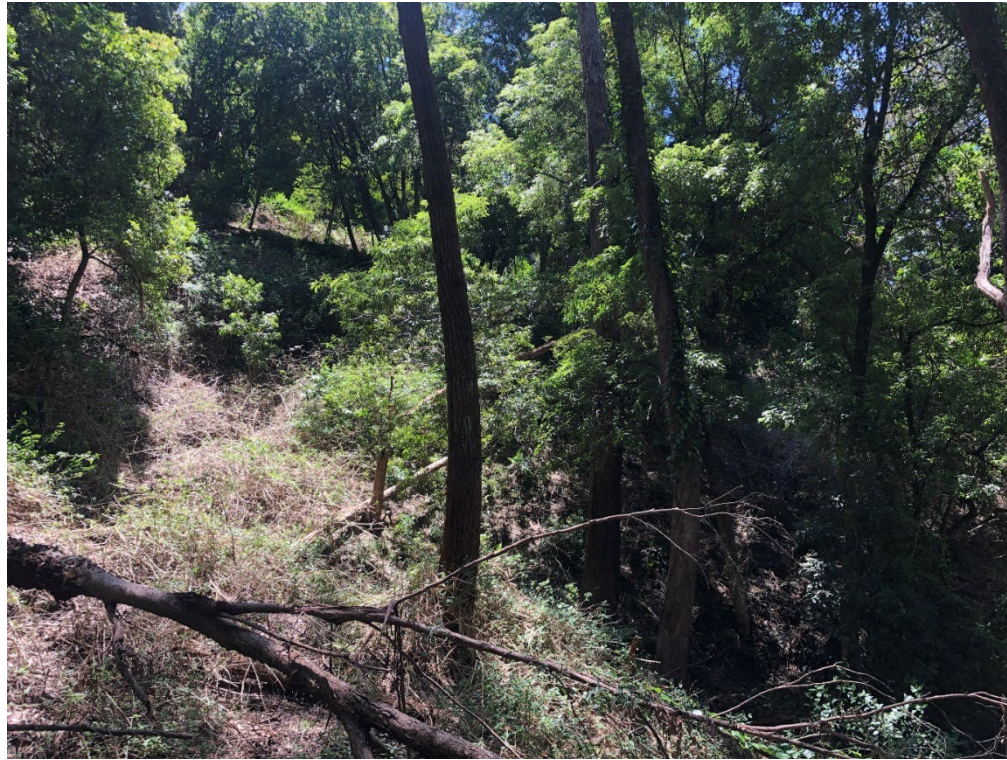
Terrain Unit 2 Photograph 13: Soil creep common within the gully.

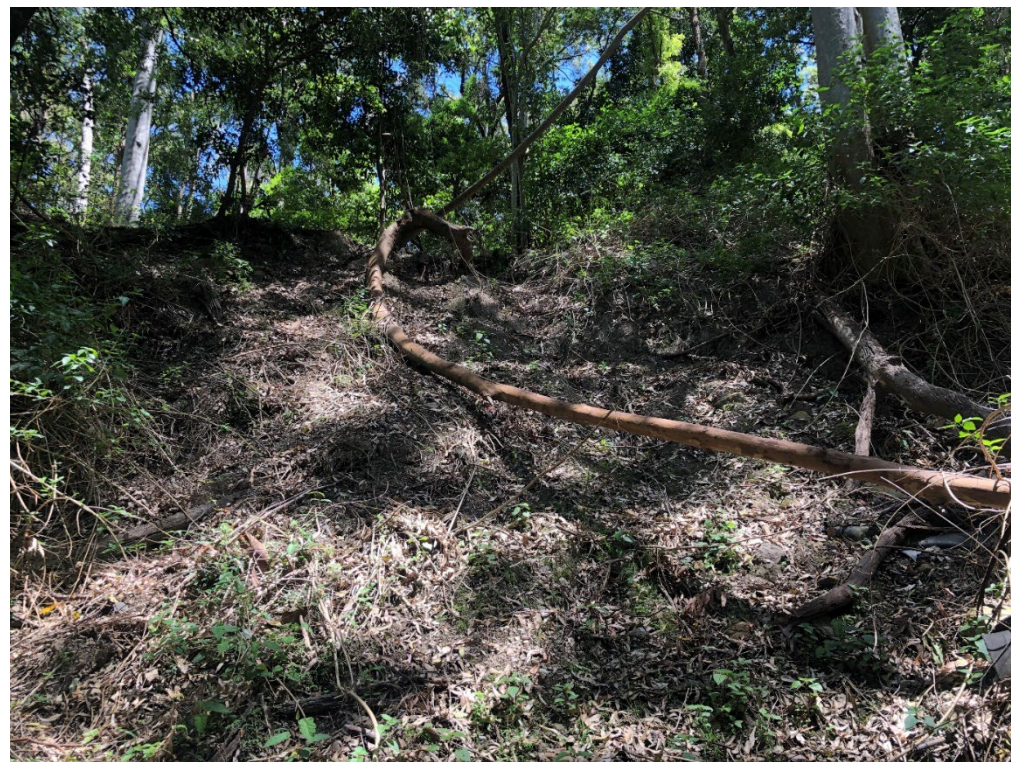
Terrain Unit 2 Photograph 15: Slip on very steep slopes upslope of Trail 31.

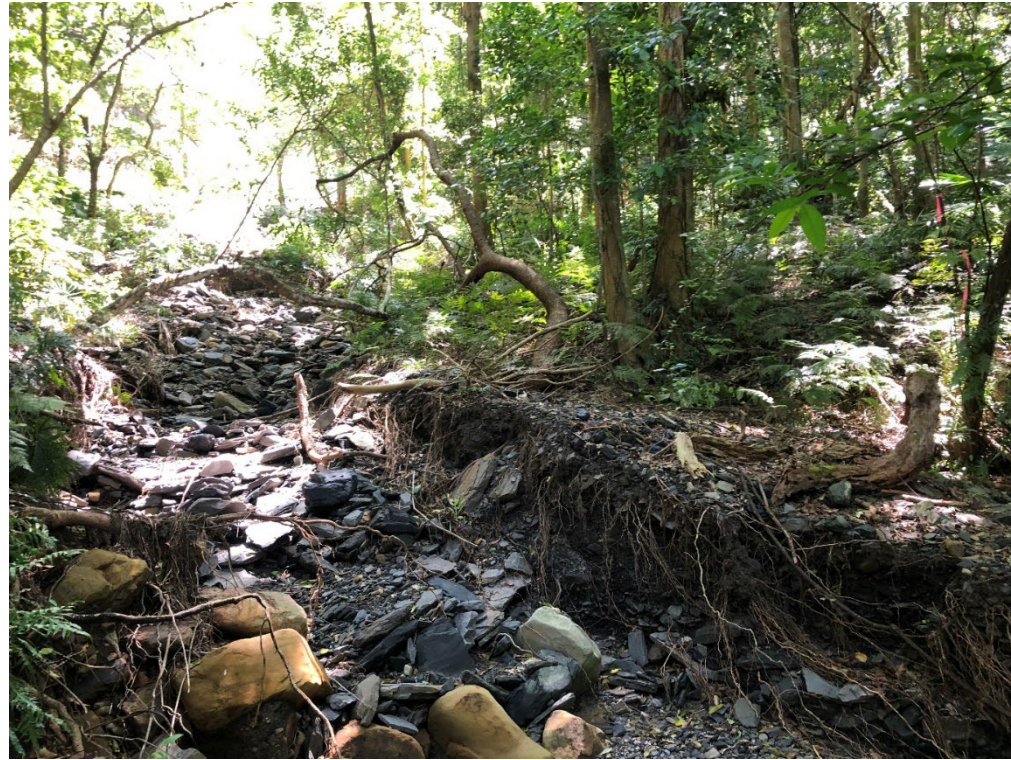
Terrain Unit 2 Photograph 17: View of Trail 32 and 33 bridge intersection.

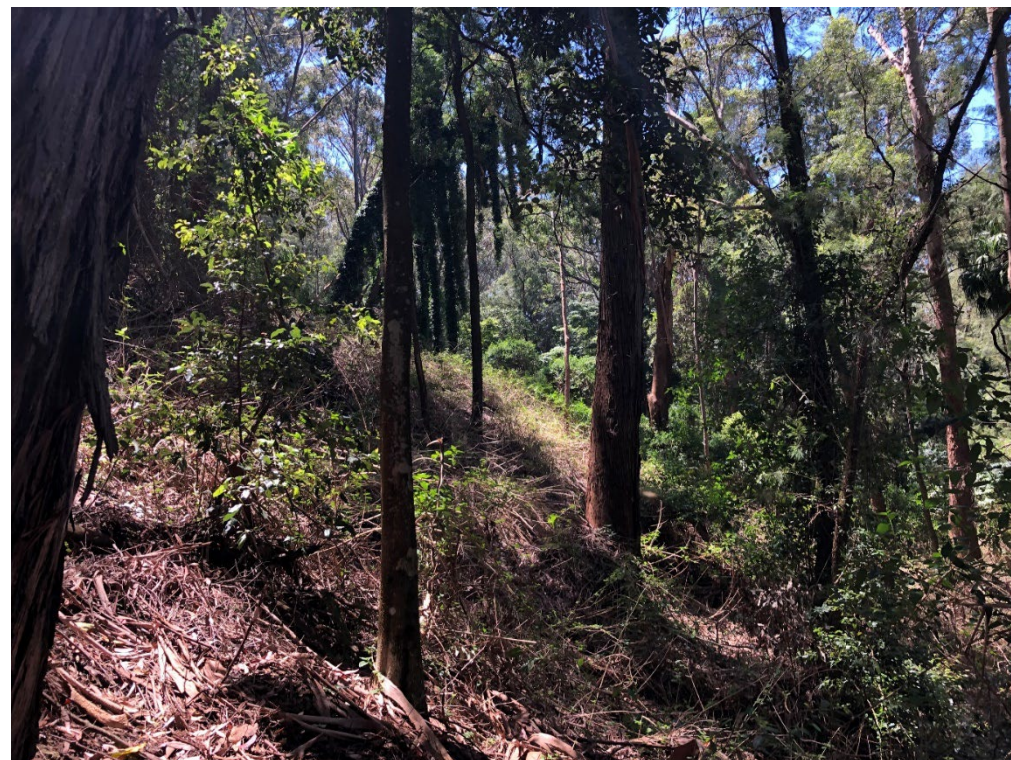
Terrain Unit 2 Photograph 19: View of the filled side of the Old Train Line.

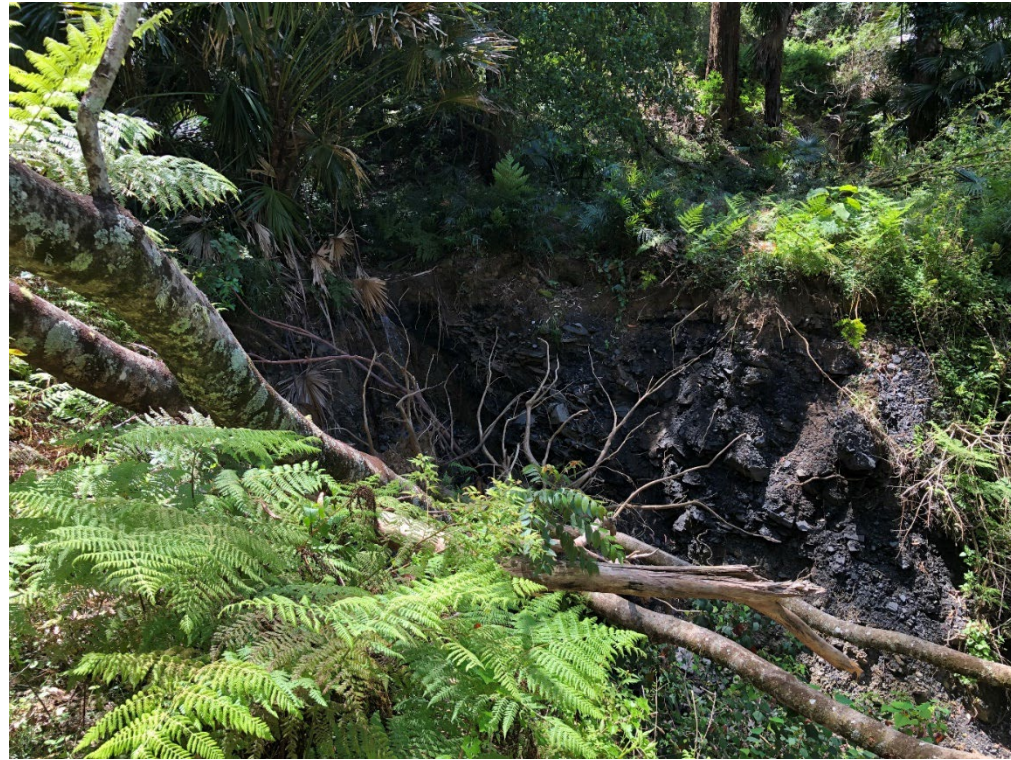
Terrain Unit 2 Photograph 21: Significant washout along the slip near a major drainage channel.

- AOC2 – Slips have occurred on the cut slopes above the trail and in the old train line filled embankment around a drainage channel. The Old Train Line is level and allows for adequate safe distance away from the cutting. In the location of slip in the fill the embankment, the trail shall be set back away from the backscarp of the filled terrain about the height of the filled embankment and hazard signage shall be implemented. Alternatively, the failed embankment slope can be reprofiled at safe batter angles with adequate erosion protection.

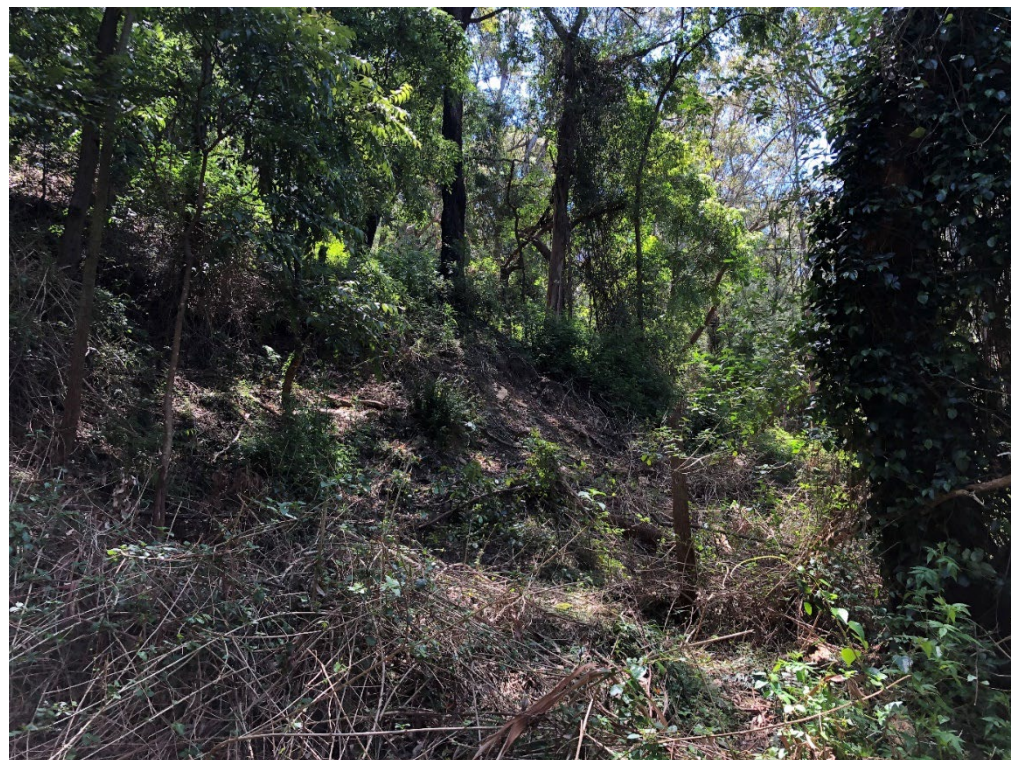
present on the slip. Rock outcrops are observed above the Old Train Line, washout and slips have occurred along the overburden soils as shown in Photograph 23 and 24. Impact from these slips are manageable.	
--	--	--

Terrain Unit 2 Photograph 23: Slippage of overburden soils above rock outcrop on cut side of slip.

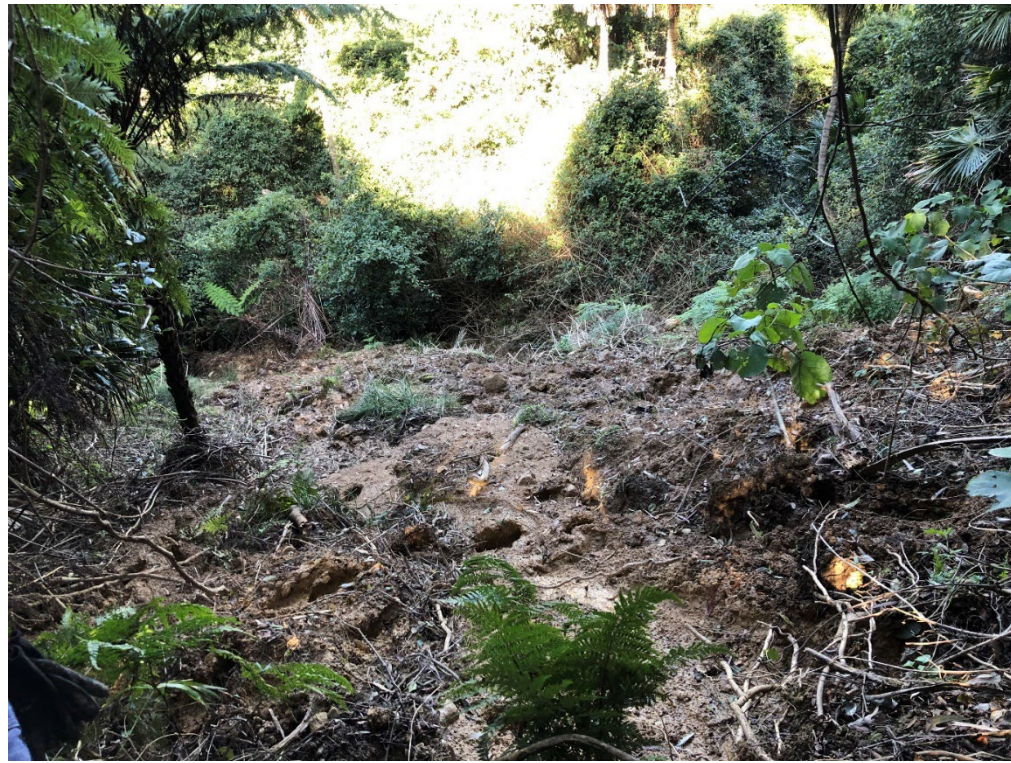
Terrain Unit 3 Photograph 5: Slip along steep section of Trail 22.

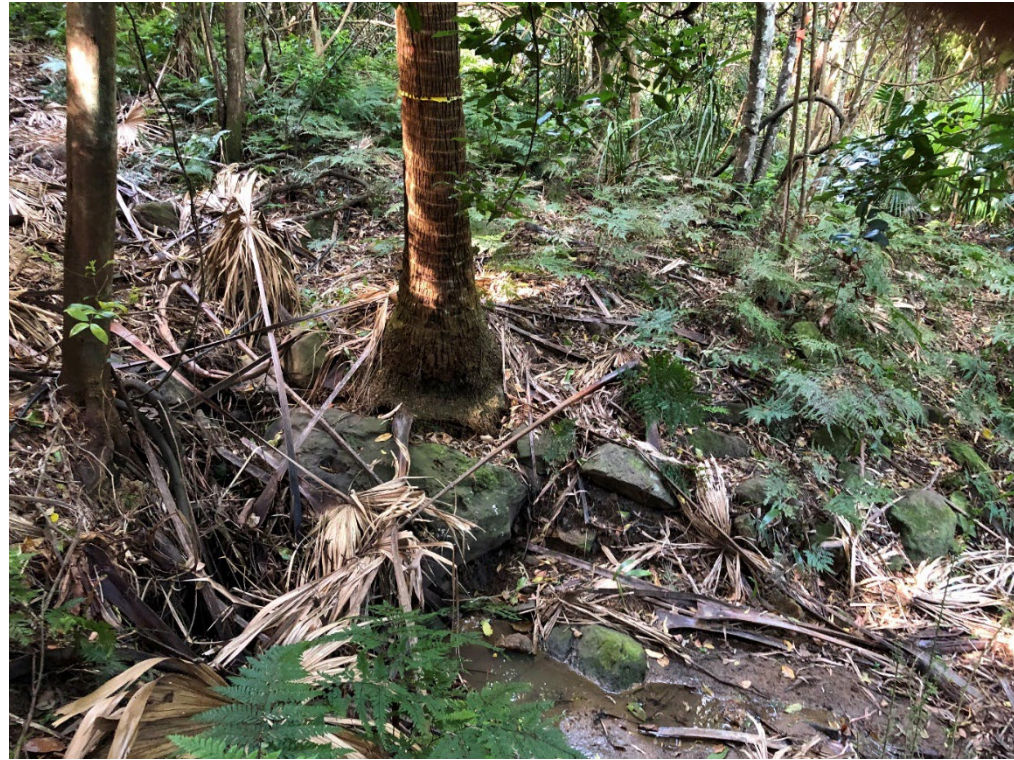
Terrain Unit 3 Photograph 9: Hummocky terrain along Trail 24.

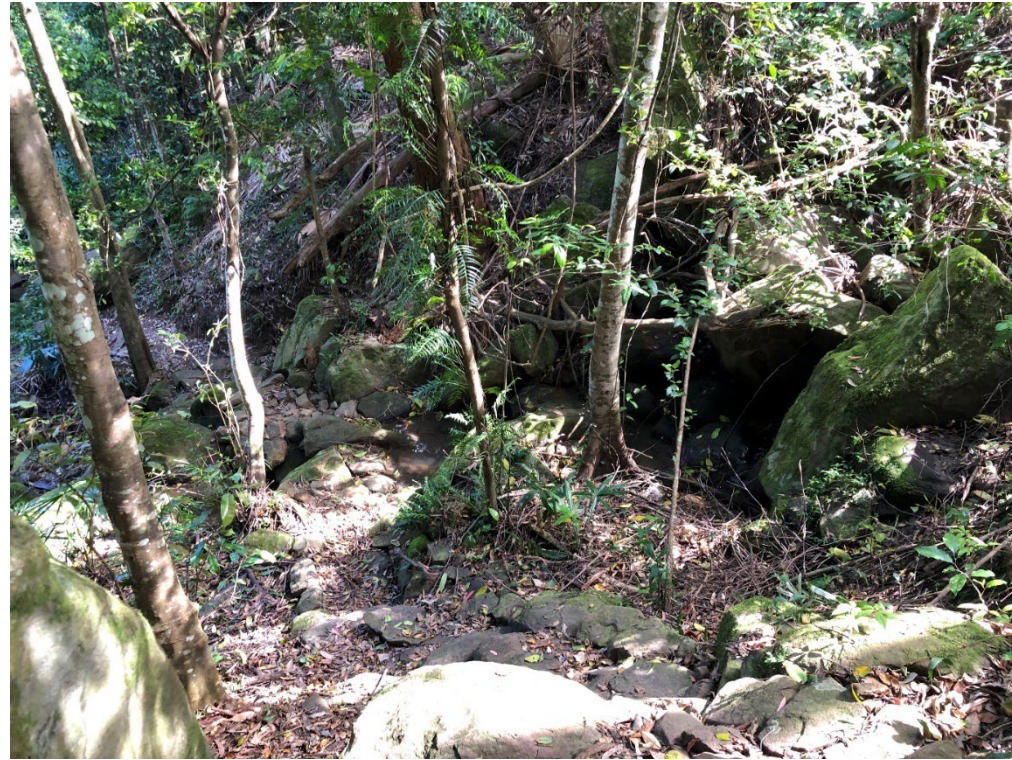
Terrain Unit 3 Photograph 13: Trail 33 crossing over channel, comprised of cobbles.

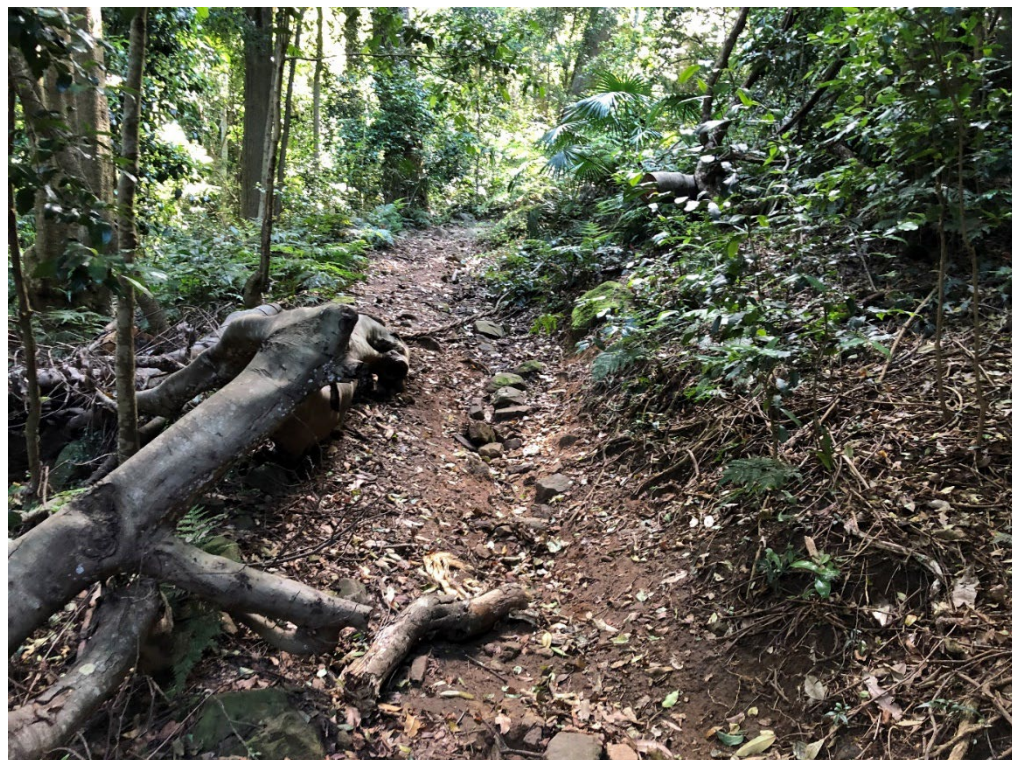
Terrain Unit 3 Photograph 15: Erosion along existing trails on the very steeply sloping portion of the trail.

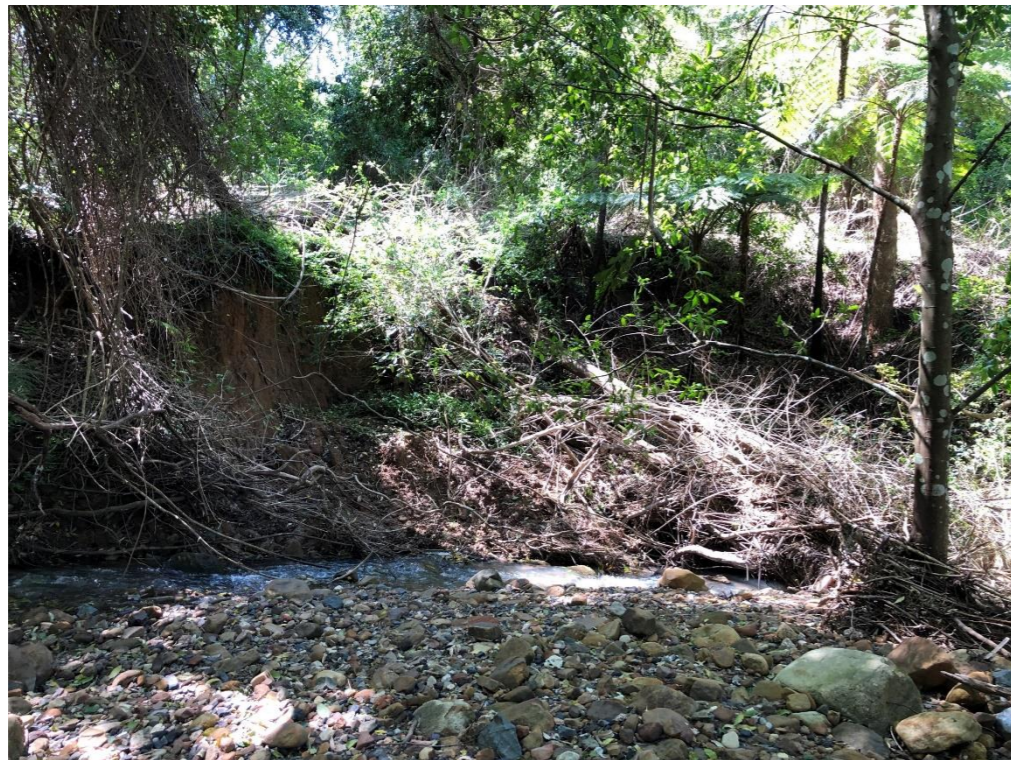
Terrain Unit 5 Photograph 5: Slumping along sections of the river.

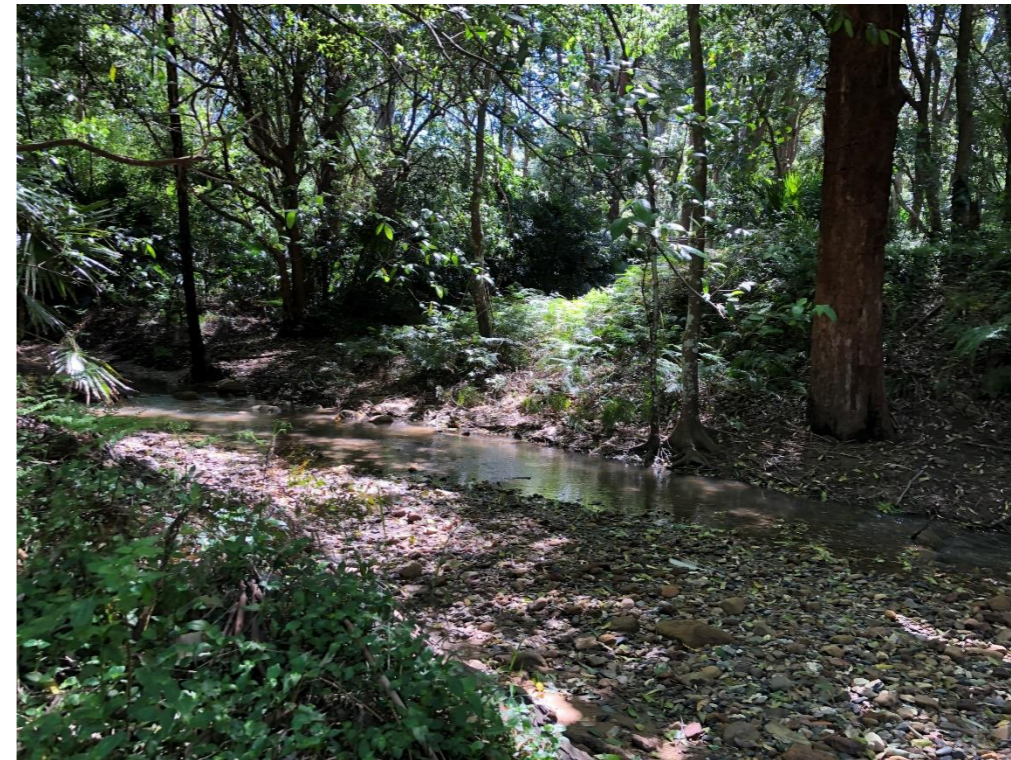
Terrain Unit 5 Photograph 6: Trail 1 Bridge Location looking northwest.
