TERRA INSIGHT

Balgownie Mountain Bike Trail Network, Balgownie NSW
Report on Preliminary Geotechnical Assessment

Our Ref: TERRA22-223.Rep1.Rev1

4 April 2023

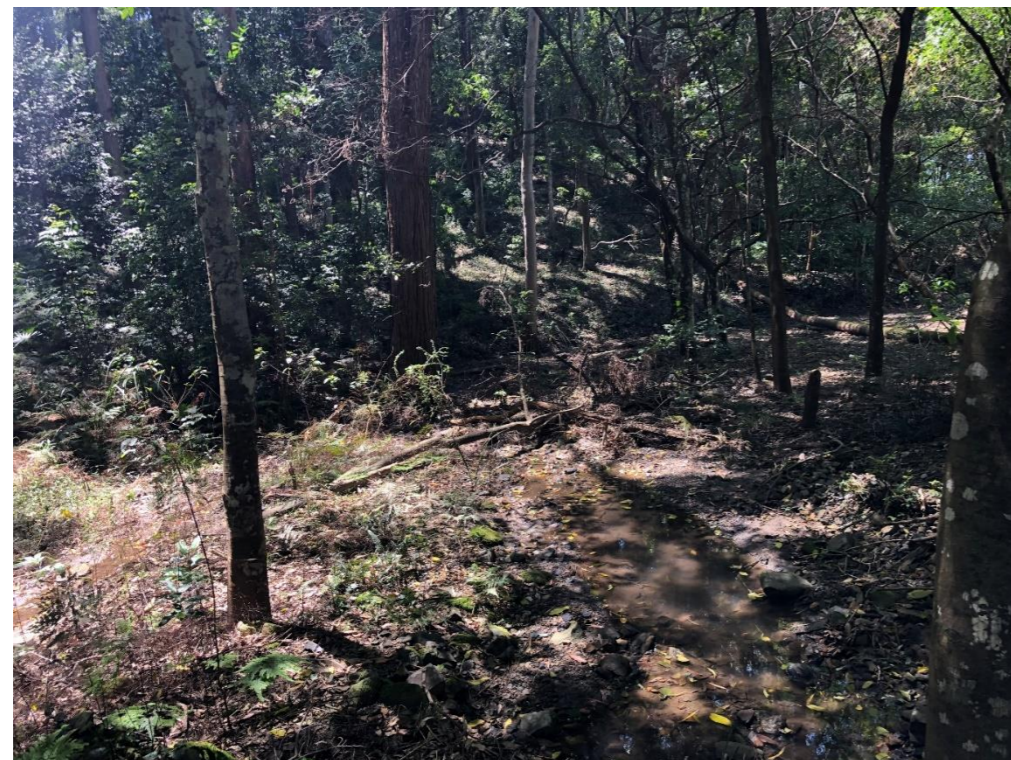
Terrain Unit 1 Photograph 11: Wide channel that Trail 30 crosses.

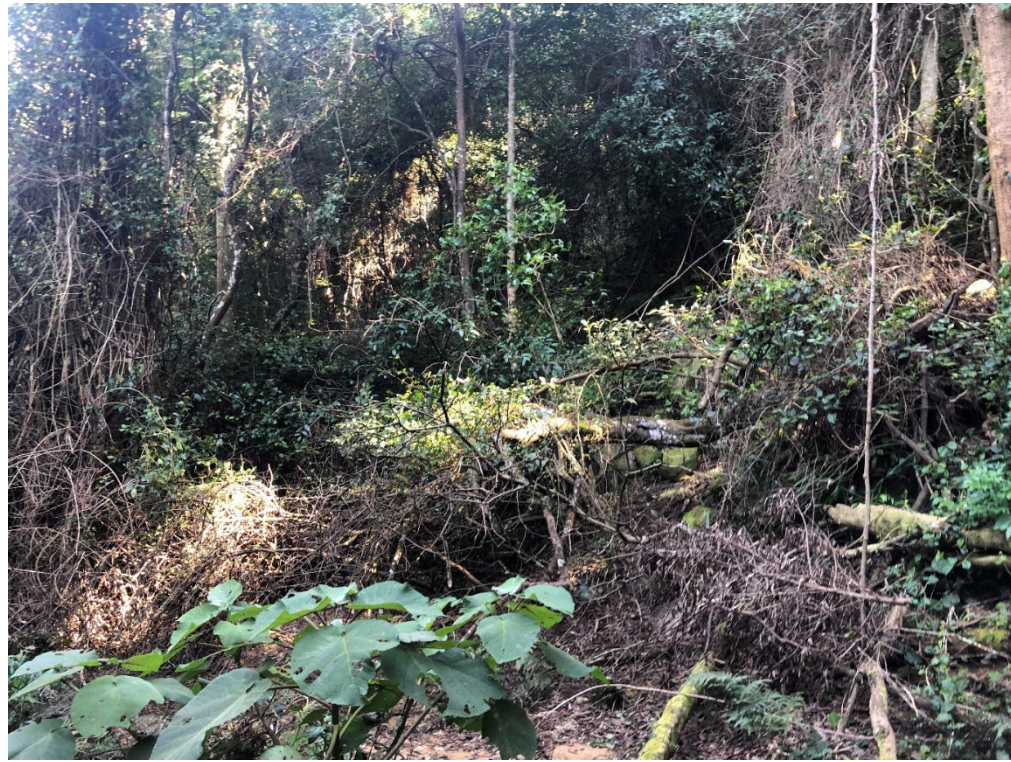
Terrain Unit 3 Photograph 1: View of level terrain below very steep benches.

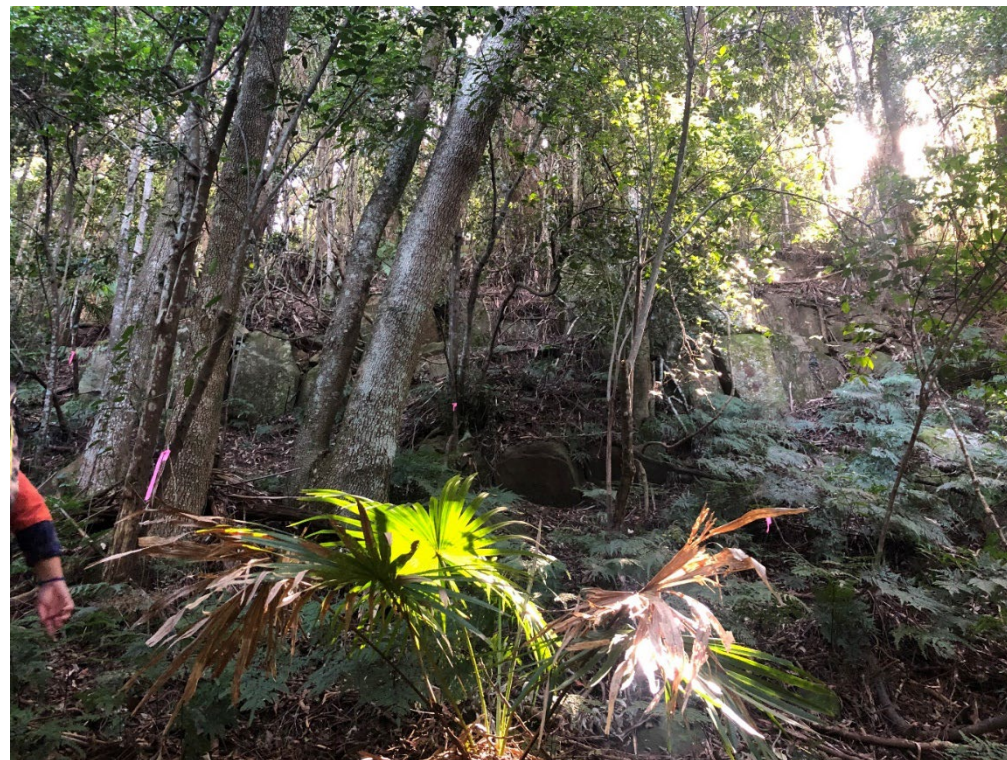
Terrain Unit 3 Photograph 3: Outcropping rock above Trail 21 and 22.

- AOC3 and AOC4 – In AOC3 Trail 21 follows the toe of the very steep slopes with rock outcrops. The steep section of the slope is about 20m high and averages about 30 to 40 degrees. It is recommended that Trail 21 is moved at least 10m to 15m downslope, so it is on level terrain away from the slope. For AOC3 and AOC4, where the trail traverses up the slope, any loose boulders that can impact the trail are to be removed, boulders that cannot be removed and jointed rock within the outcrop are to be stabilised with rock bolts or similar. The trail is to comprise of a full bench and should have rockfall hazard warning signage along the trail. Surface water can be trained to flow away from these section using swales into natural gullies.
